Natural Processes for the Restoration of Drastically Disturbed Sites

David F. Polster, M.Sc., R.P.Bio., CERP
Polster Environmental Services Ltd.

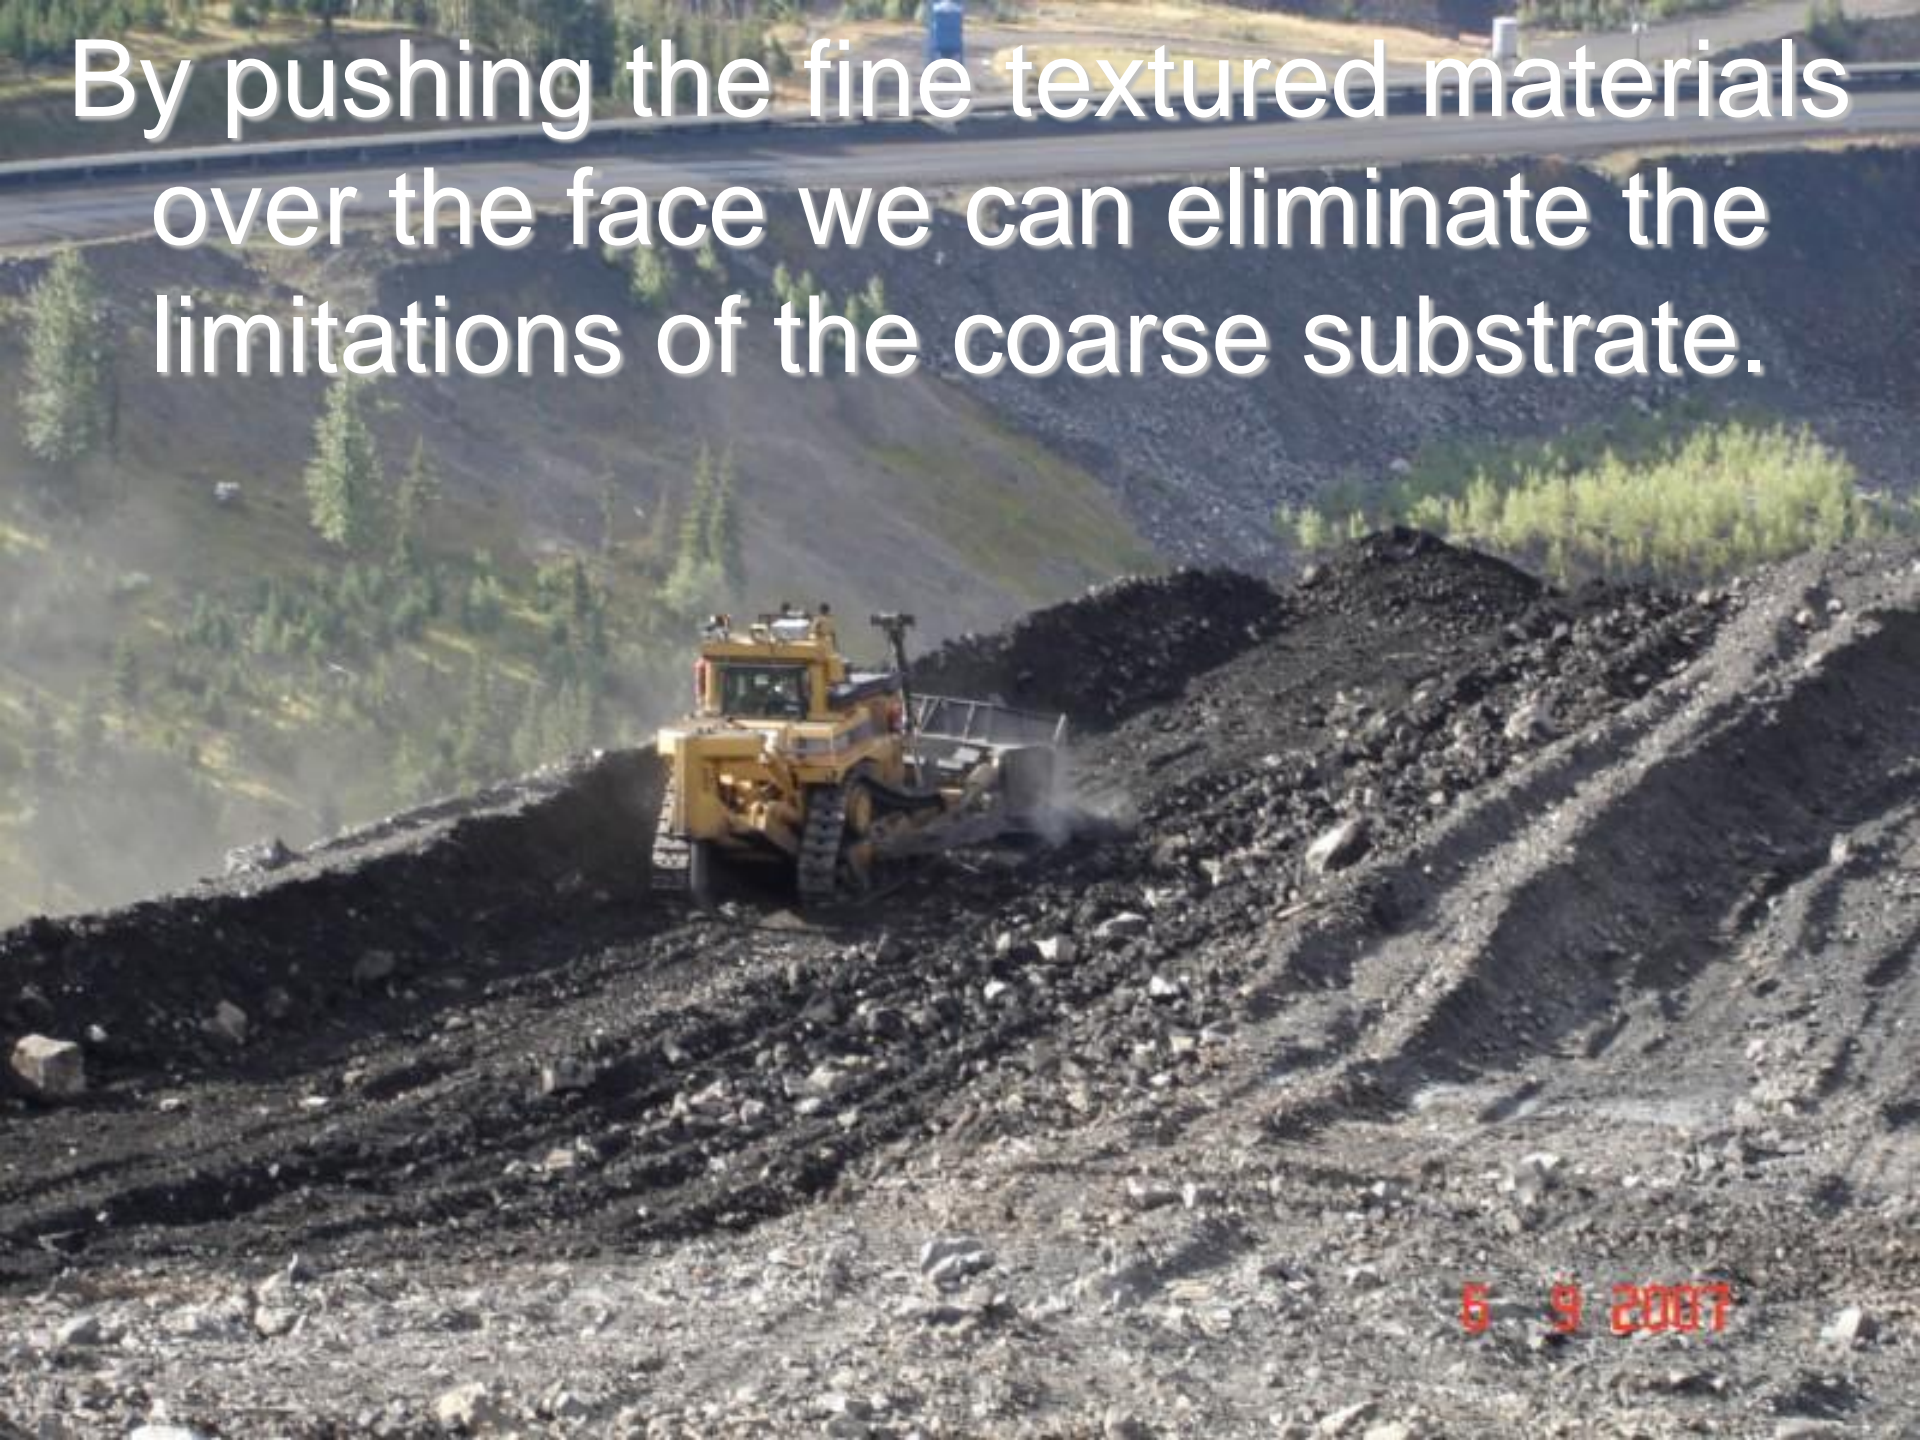
6 9 2007

By making the surface rough and loose
we can control erosion.

No seeding or topsoil is needed to re-
grow a forest on this site using natural
processes.

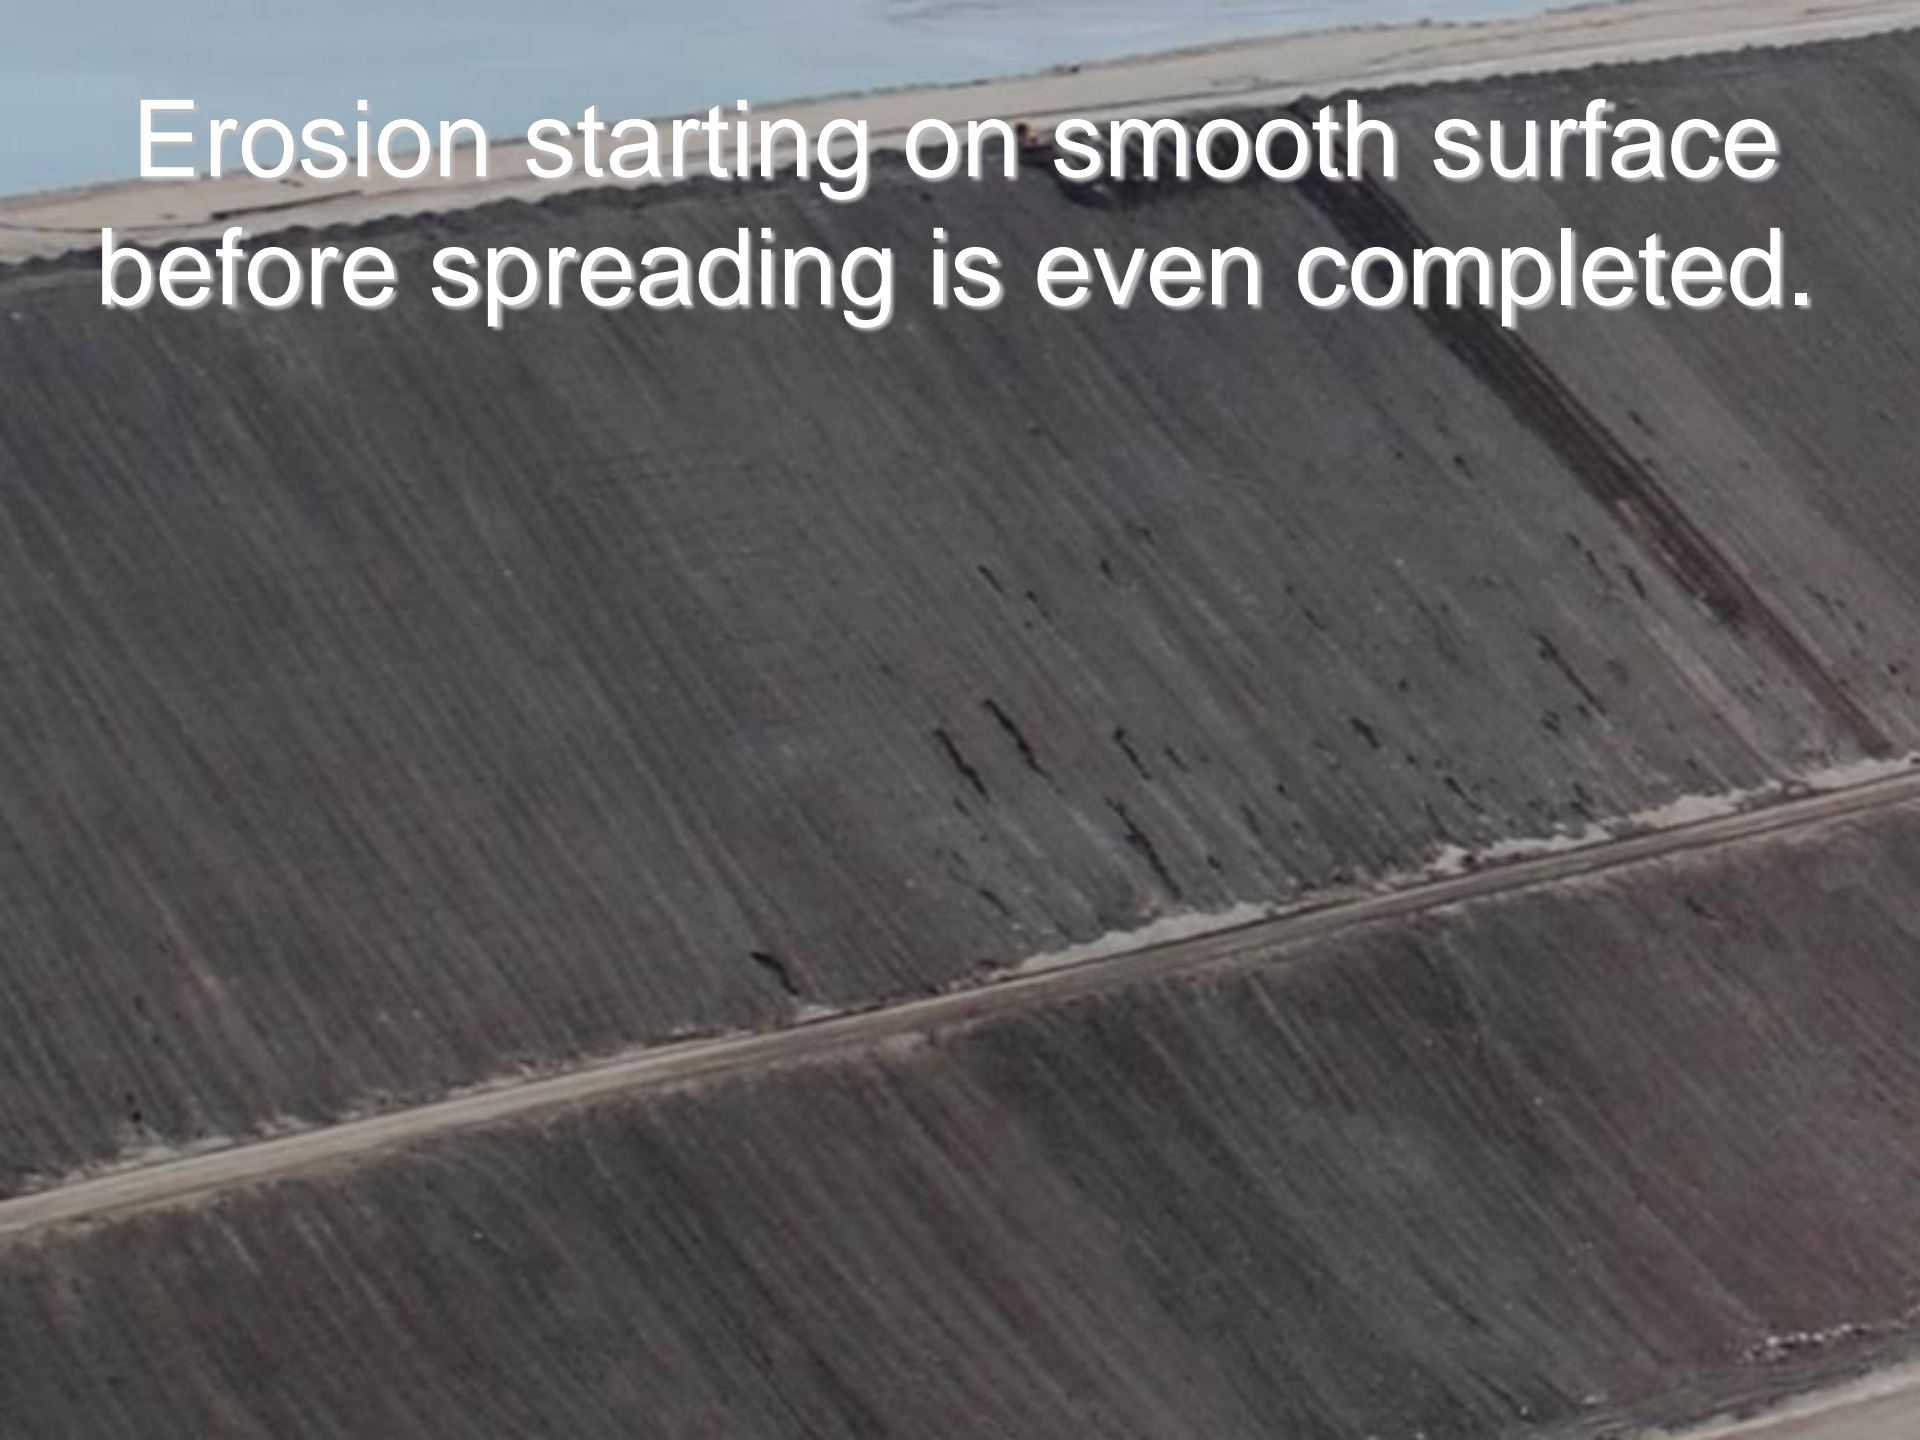
Erosion starting on smooth surface
before spreading is even completed.

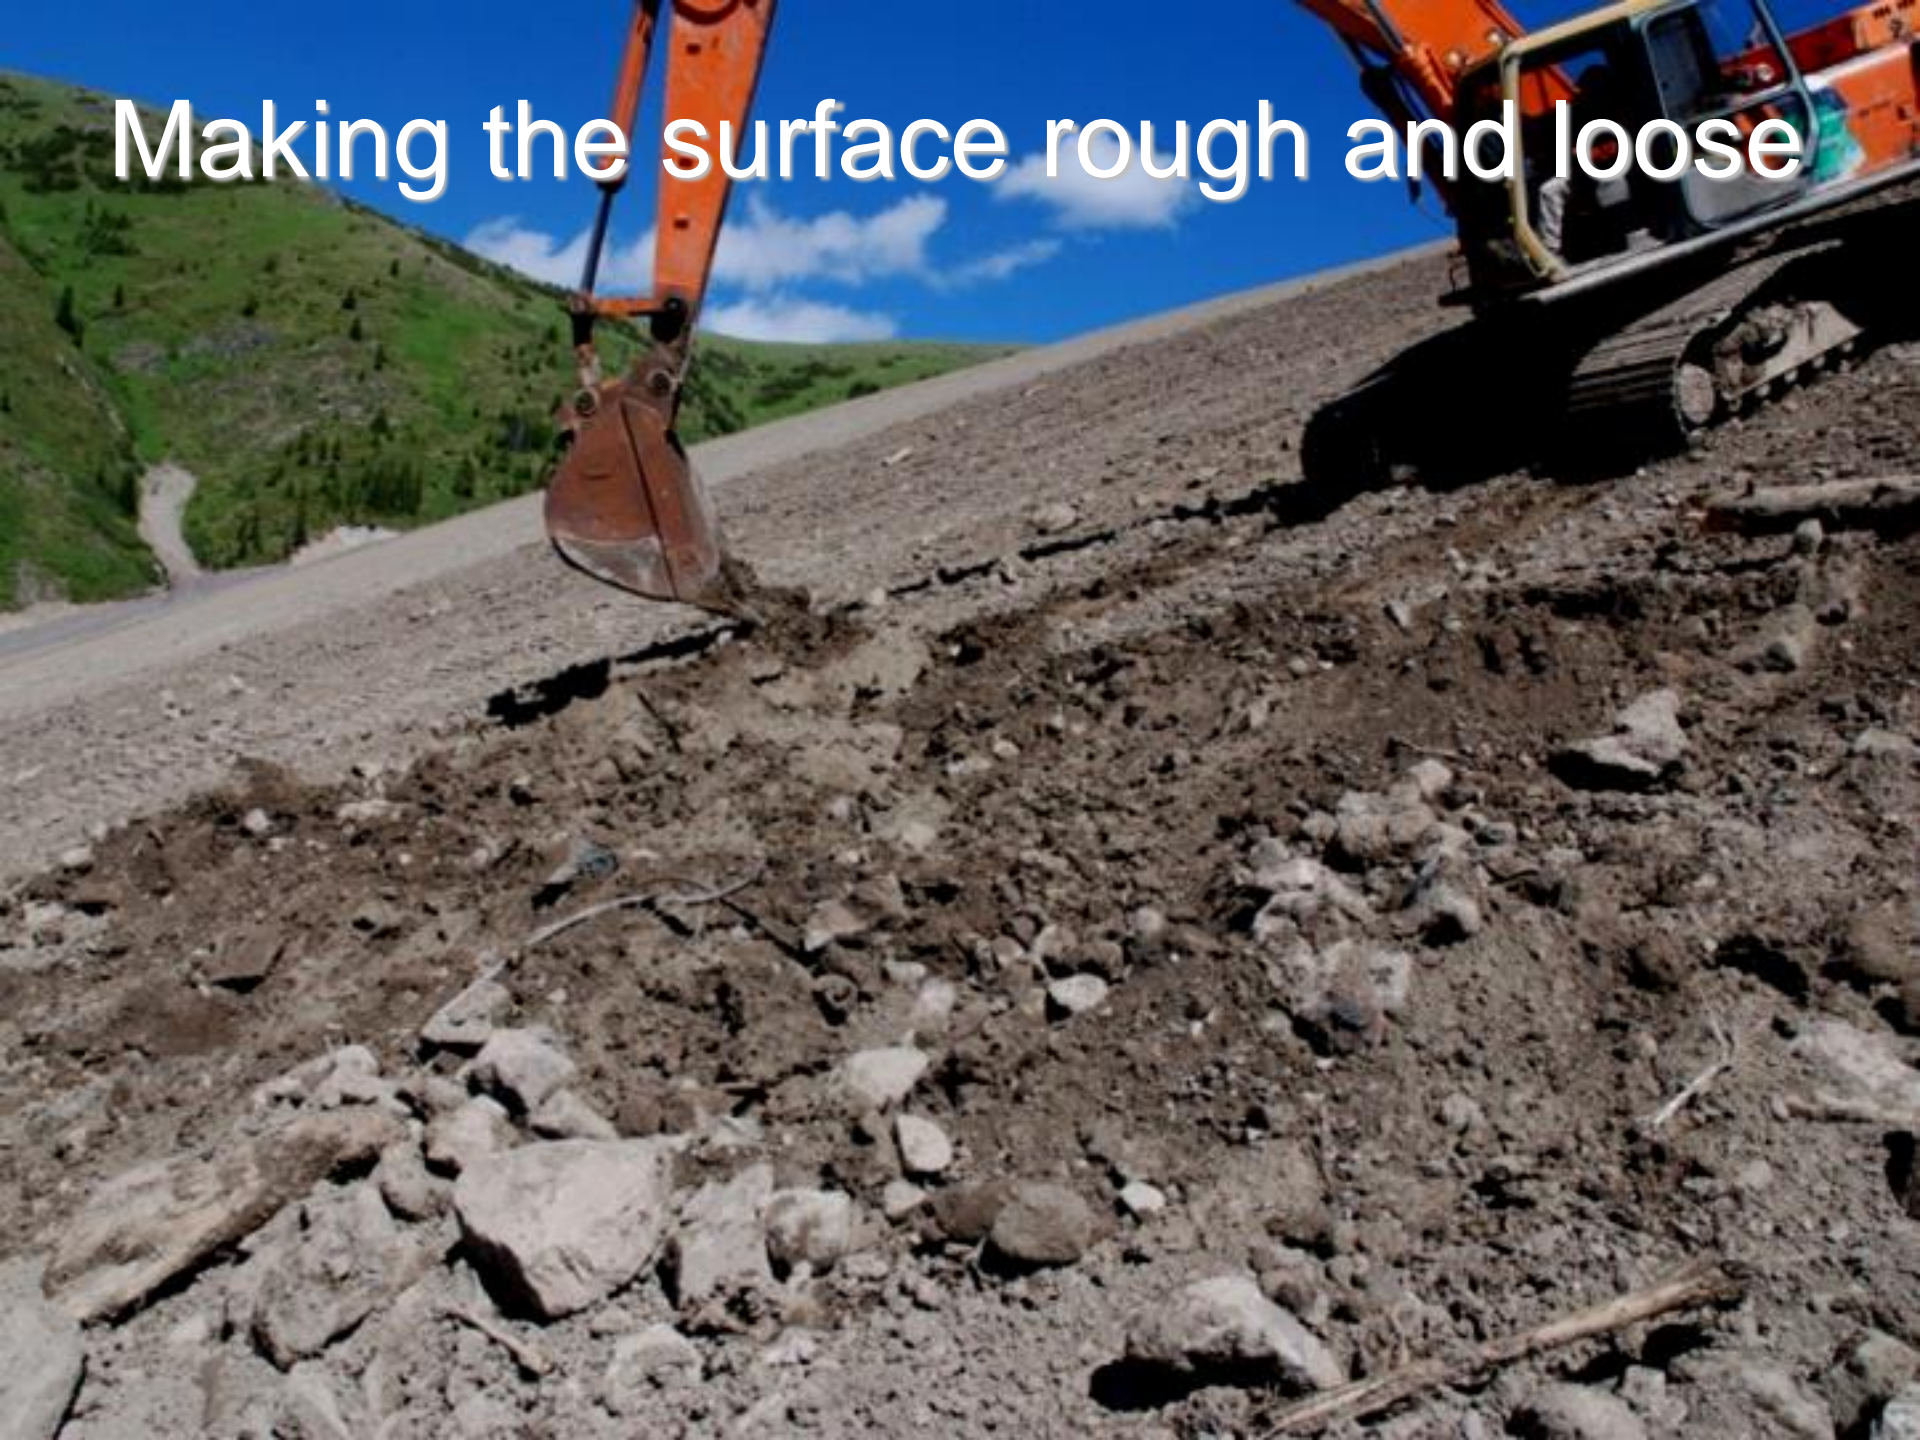
Making the surface rough and loose

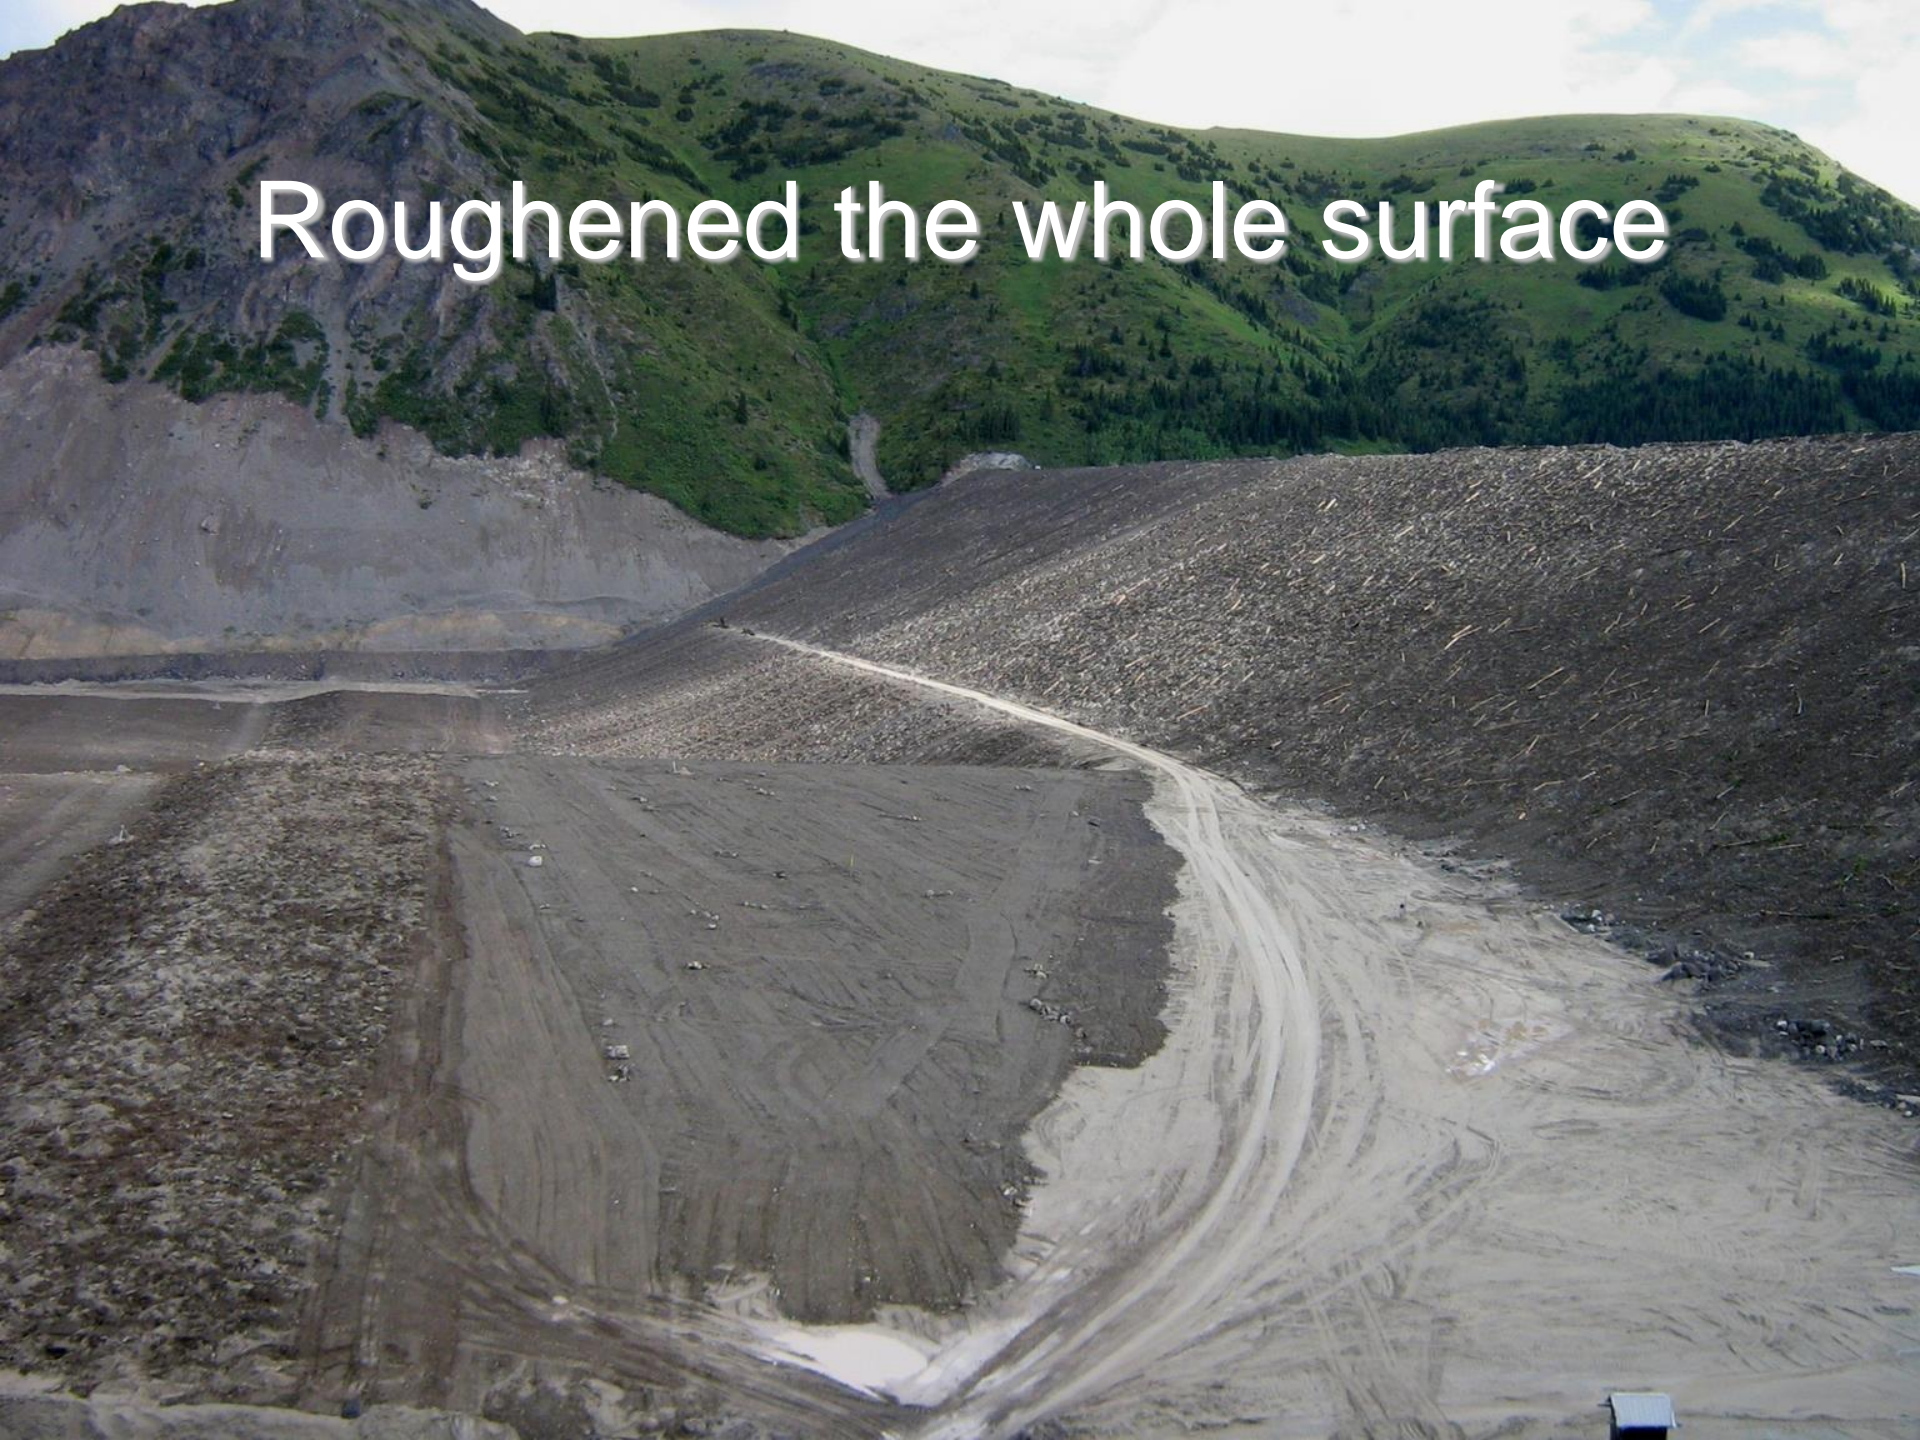
Roughened the whole surface

Cost of rough and loose treatment at Kemess Mine was \$715/ha while hydroseeding costs over \$3,500/ha

Making surfaces rough and loose controls erosion and enhances native species establishment.

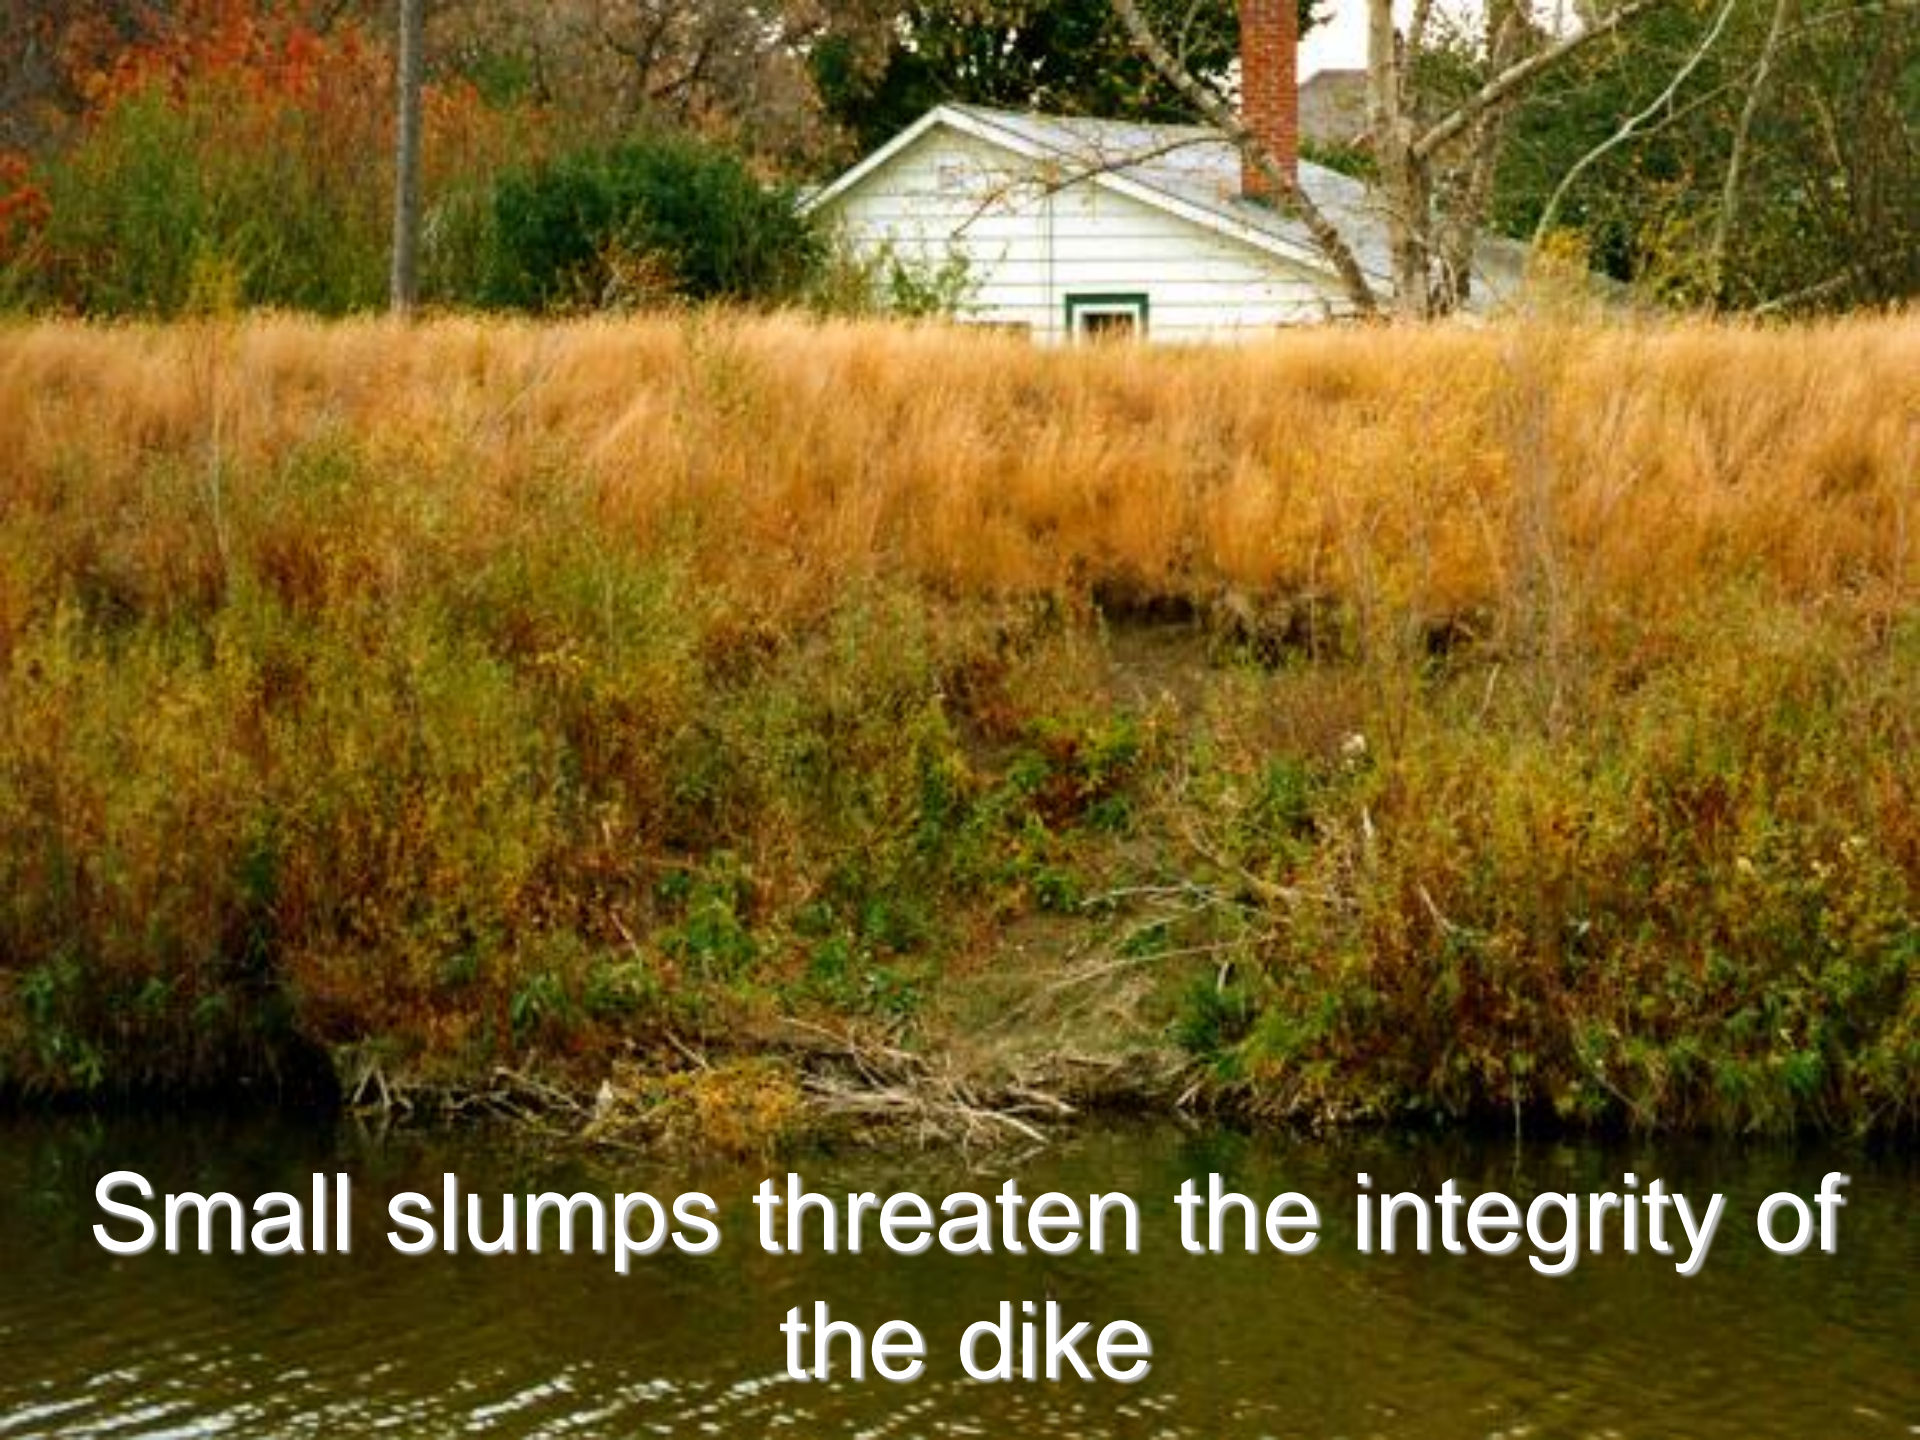
Small slumps threaten the integrity of
the dike

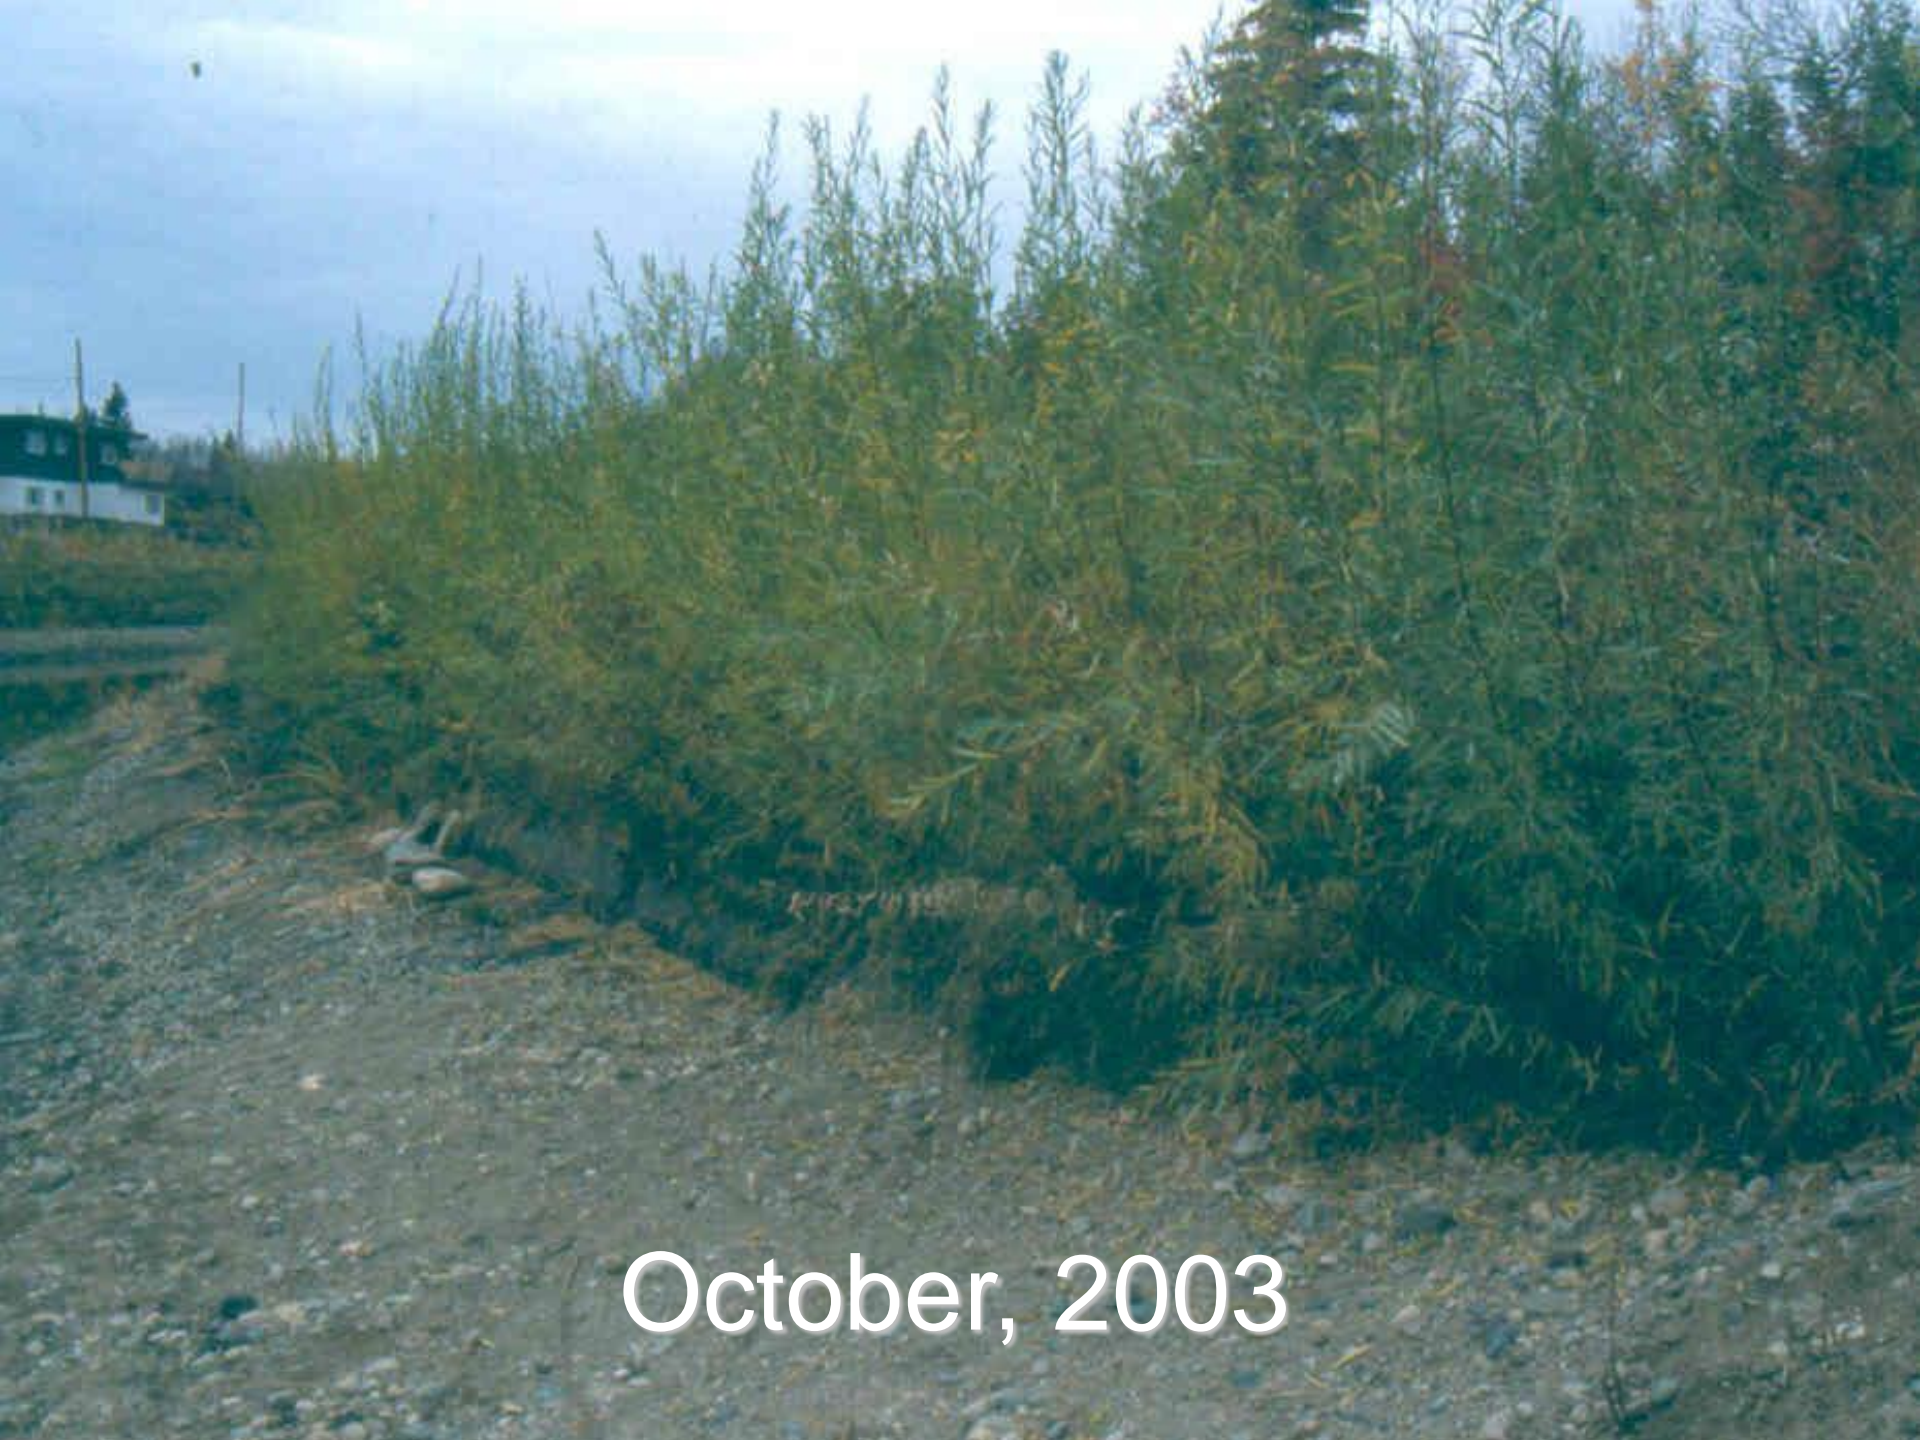
Soil bioengineering treatments incorporated into slope designs

May, 2003

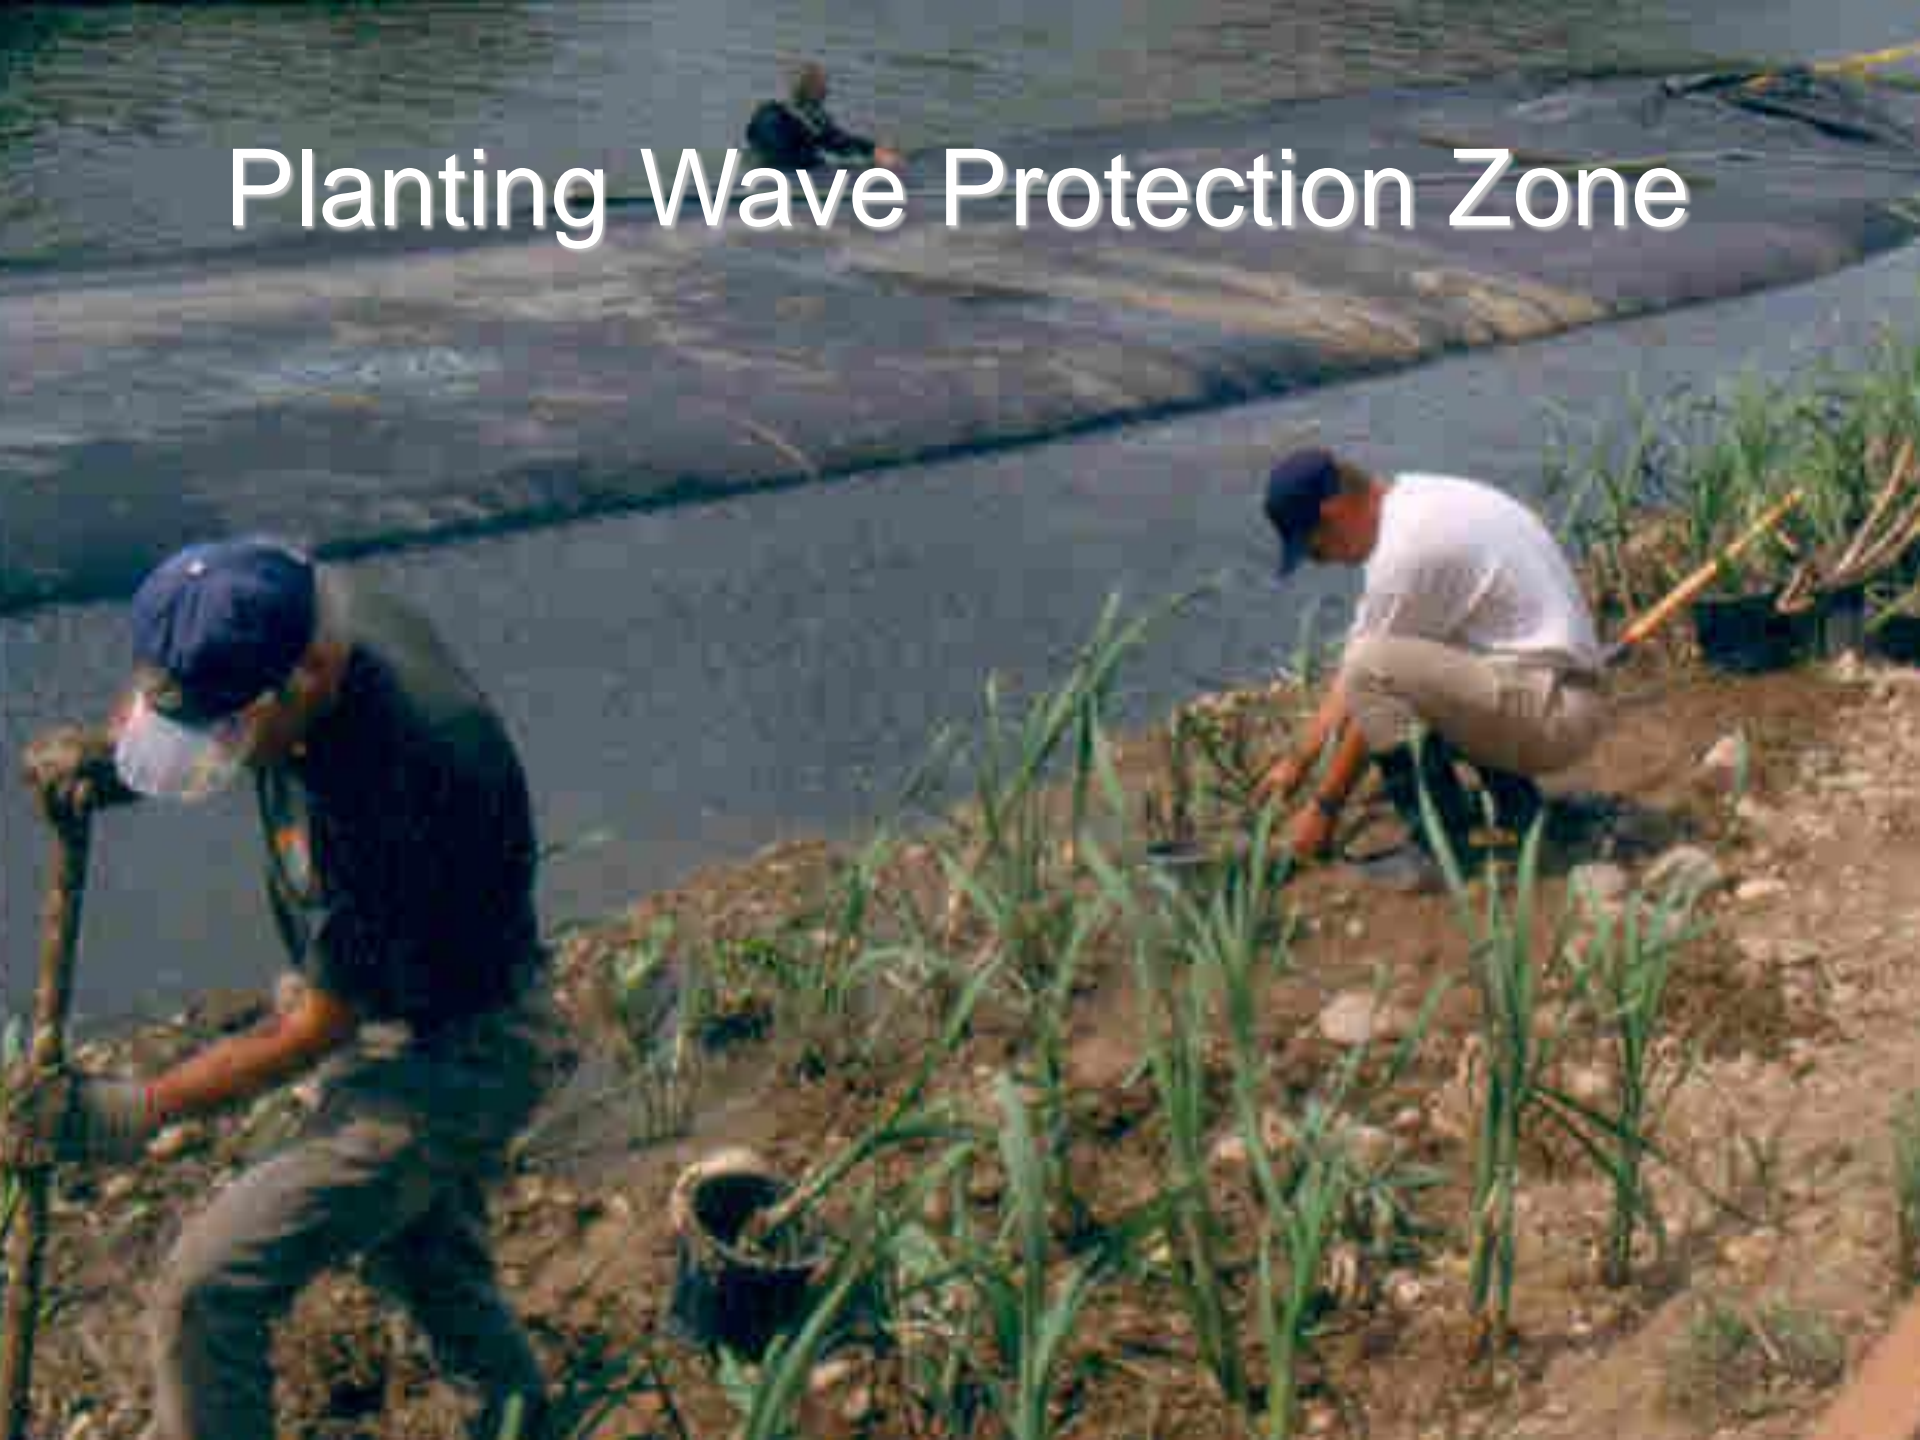
Collecting plants for Wave Protection
Zone

Planting Wave Protection Zone

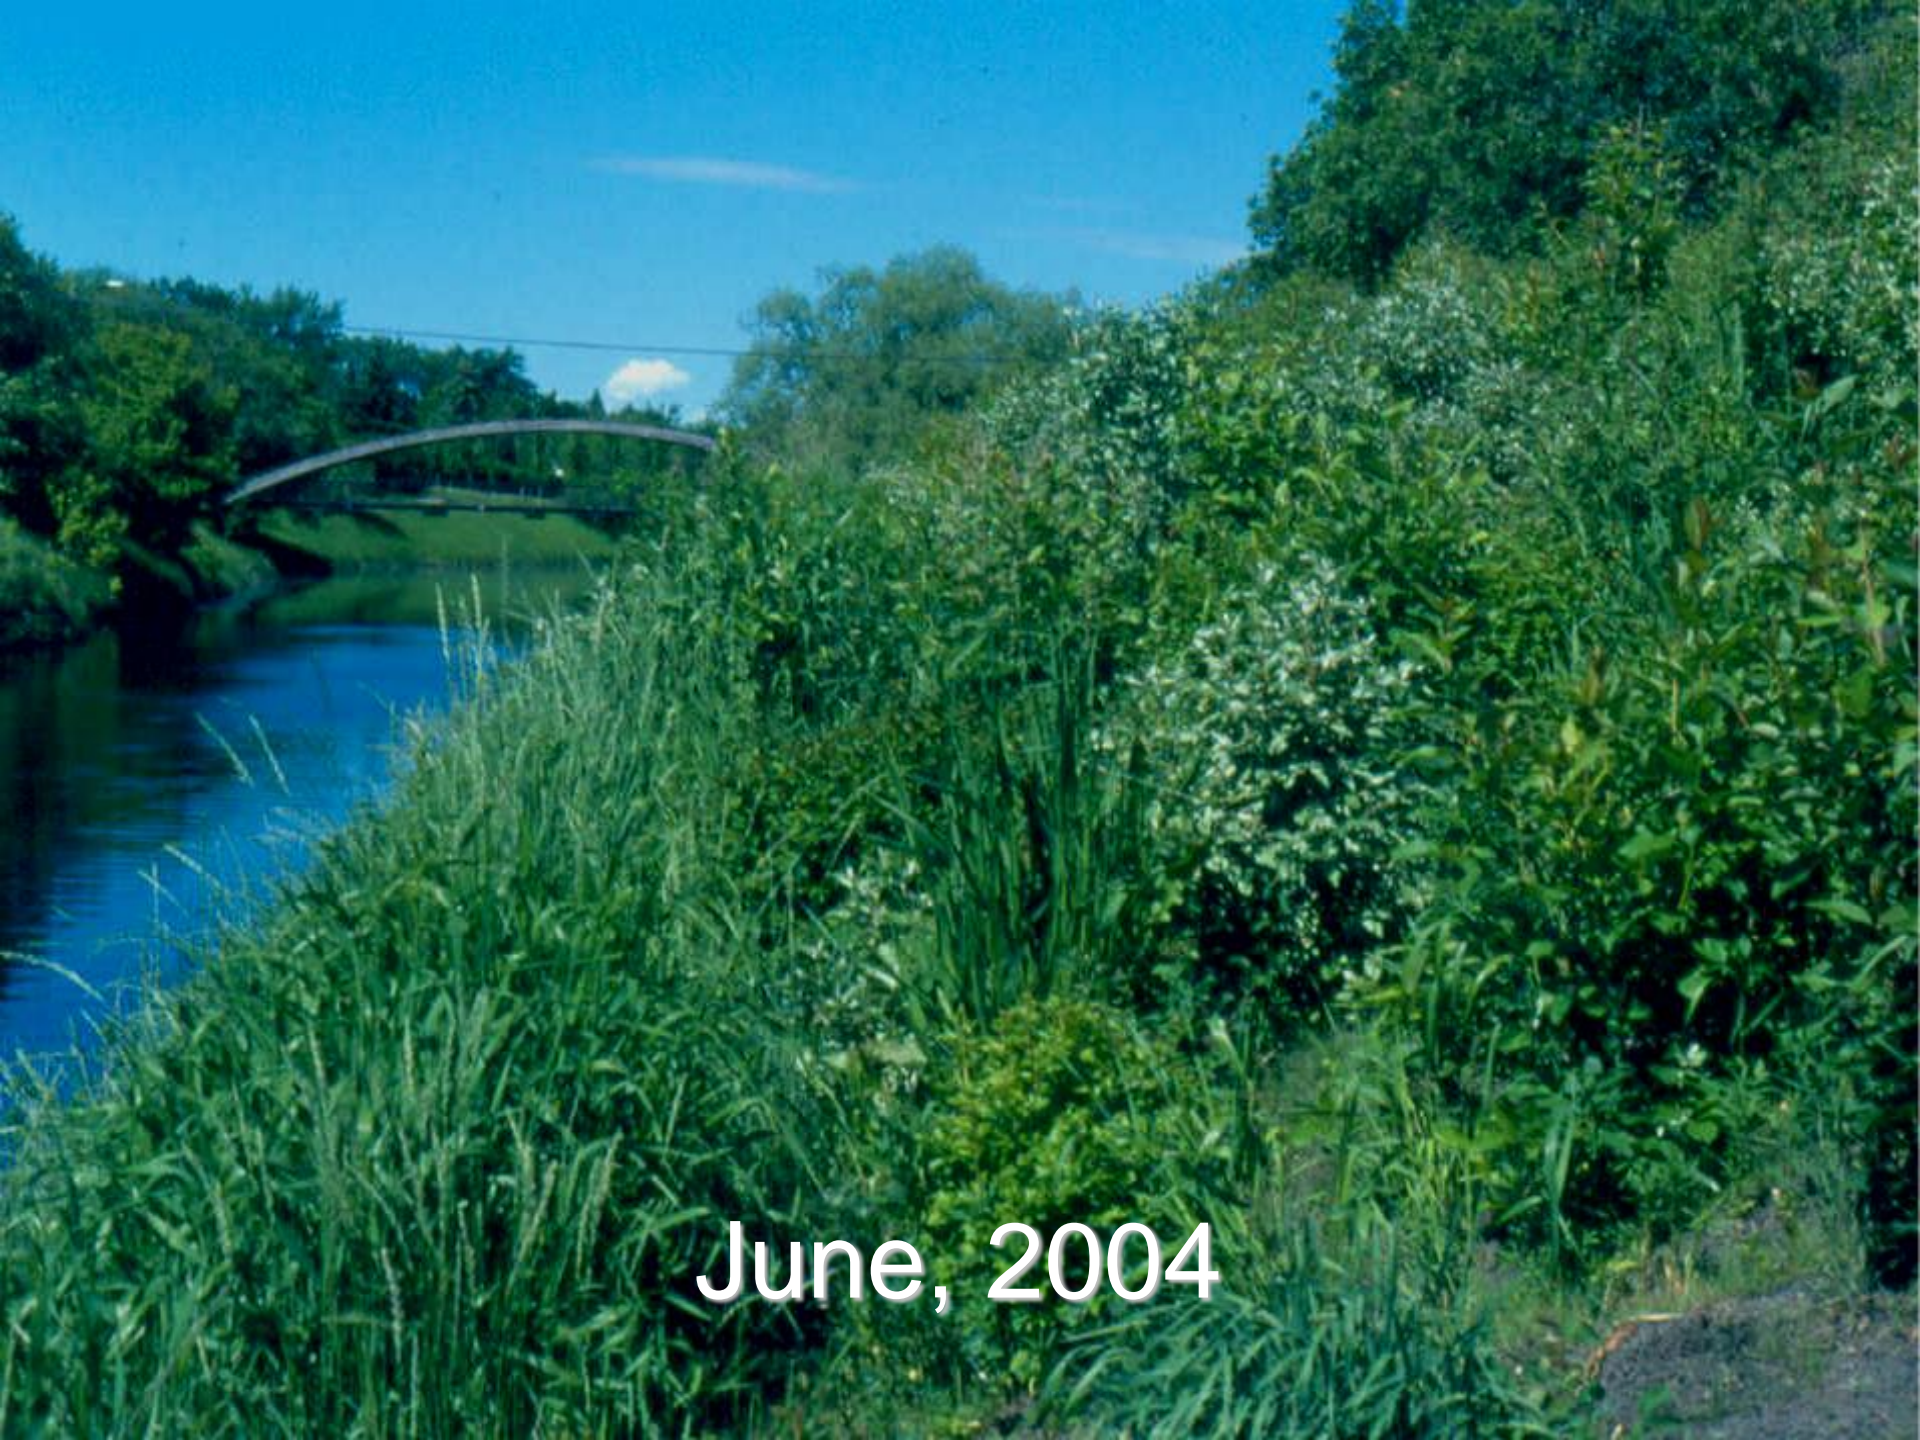
Installing cuttings in Tall Shrub Zone
