Natural Processes for the Restoration of Drastically Disturbed Sites

David F. Polster, M.Sc., R.P.Bio., CERP
Polster Environmental Services Ltd.

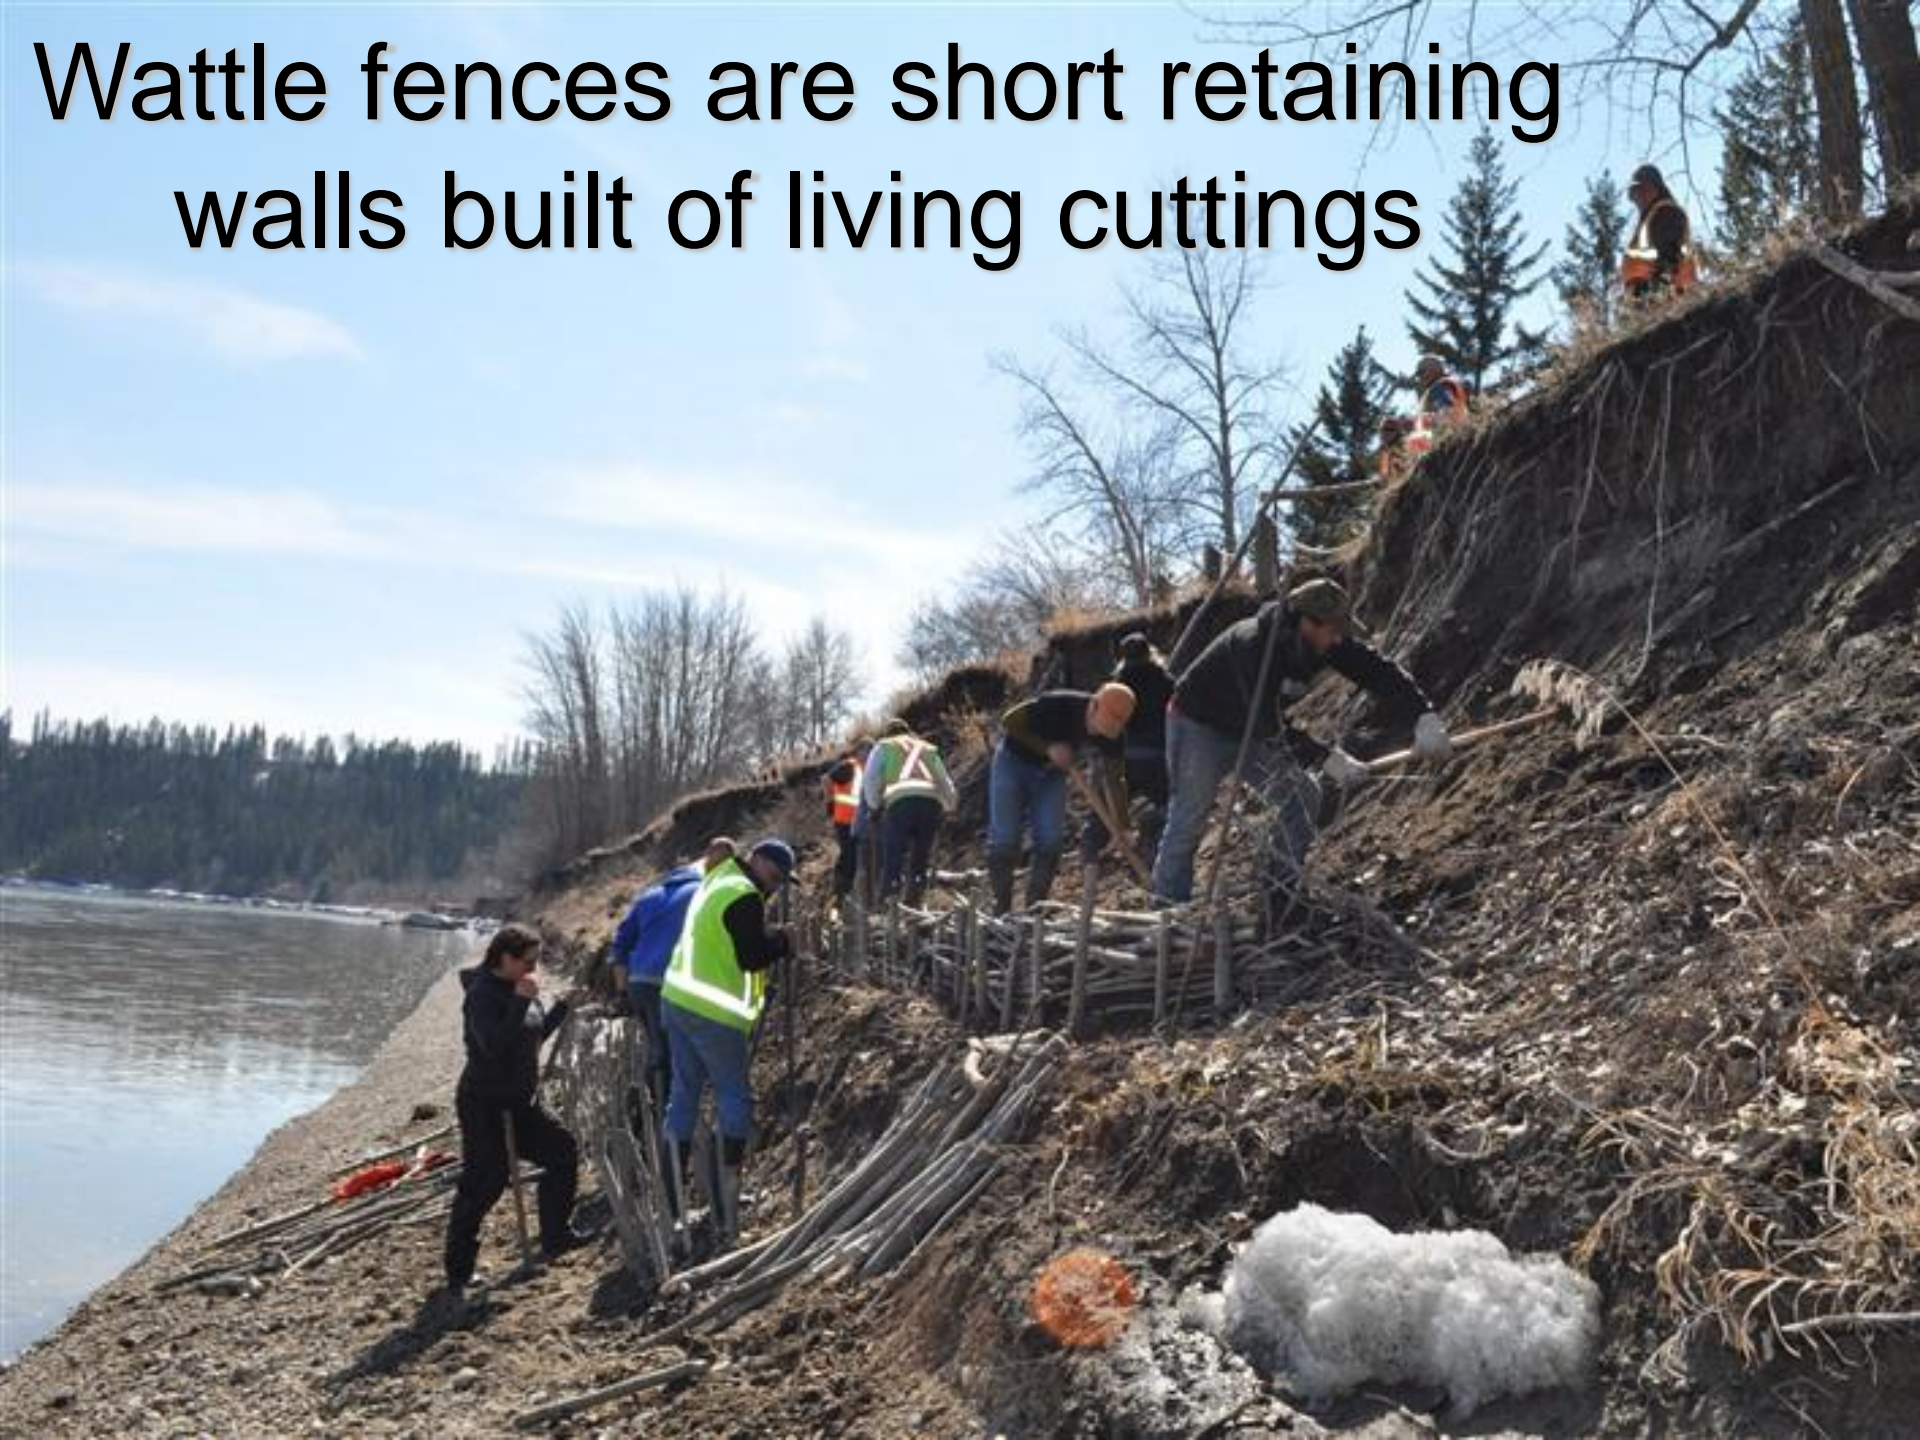
Wattle fences are short retaining walls built of living cuttings

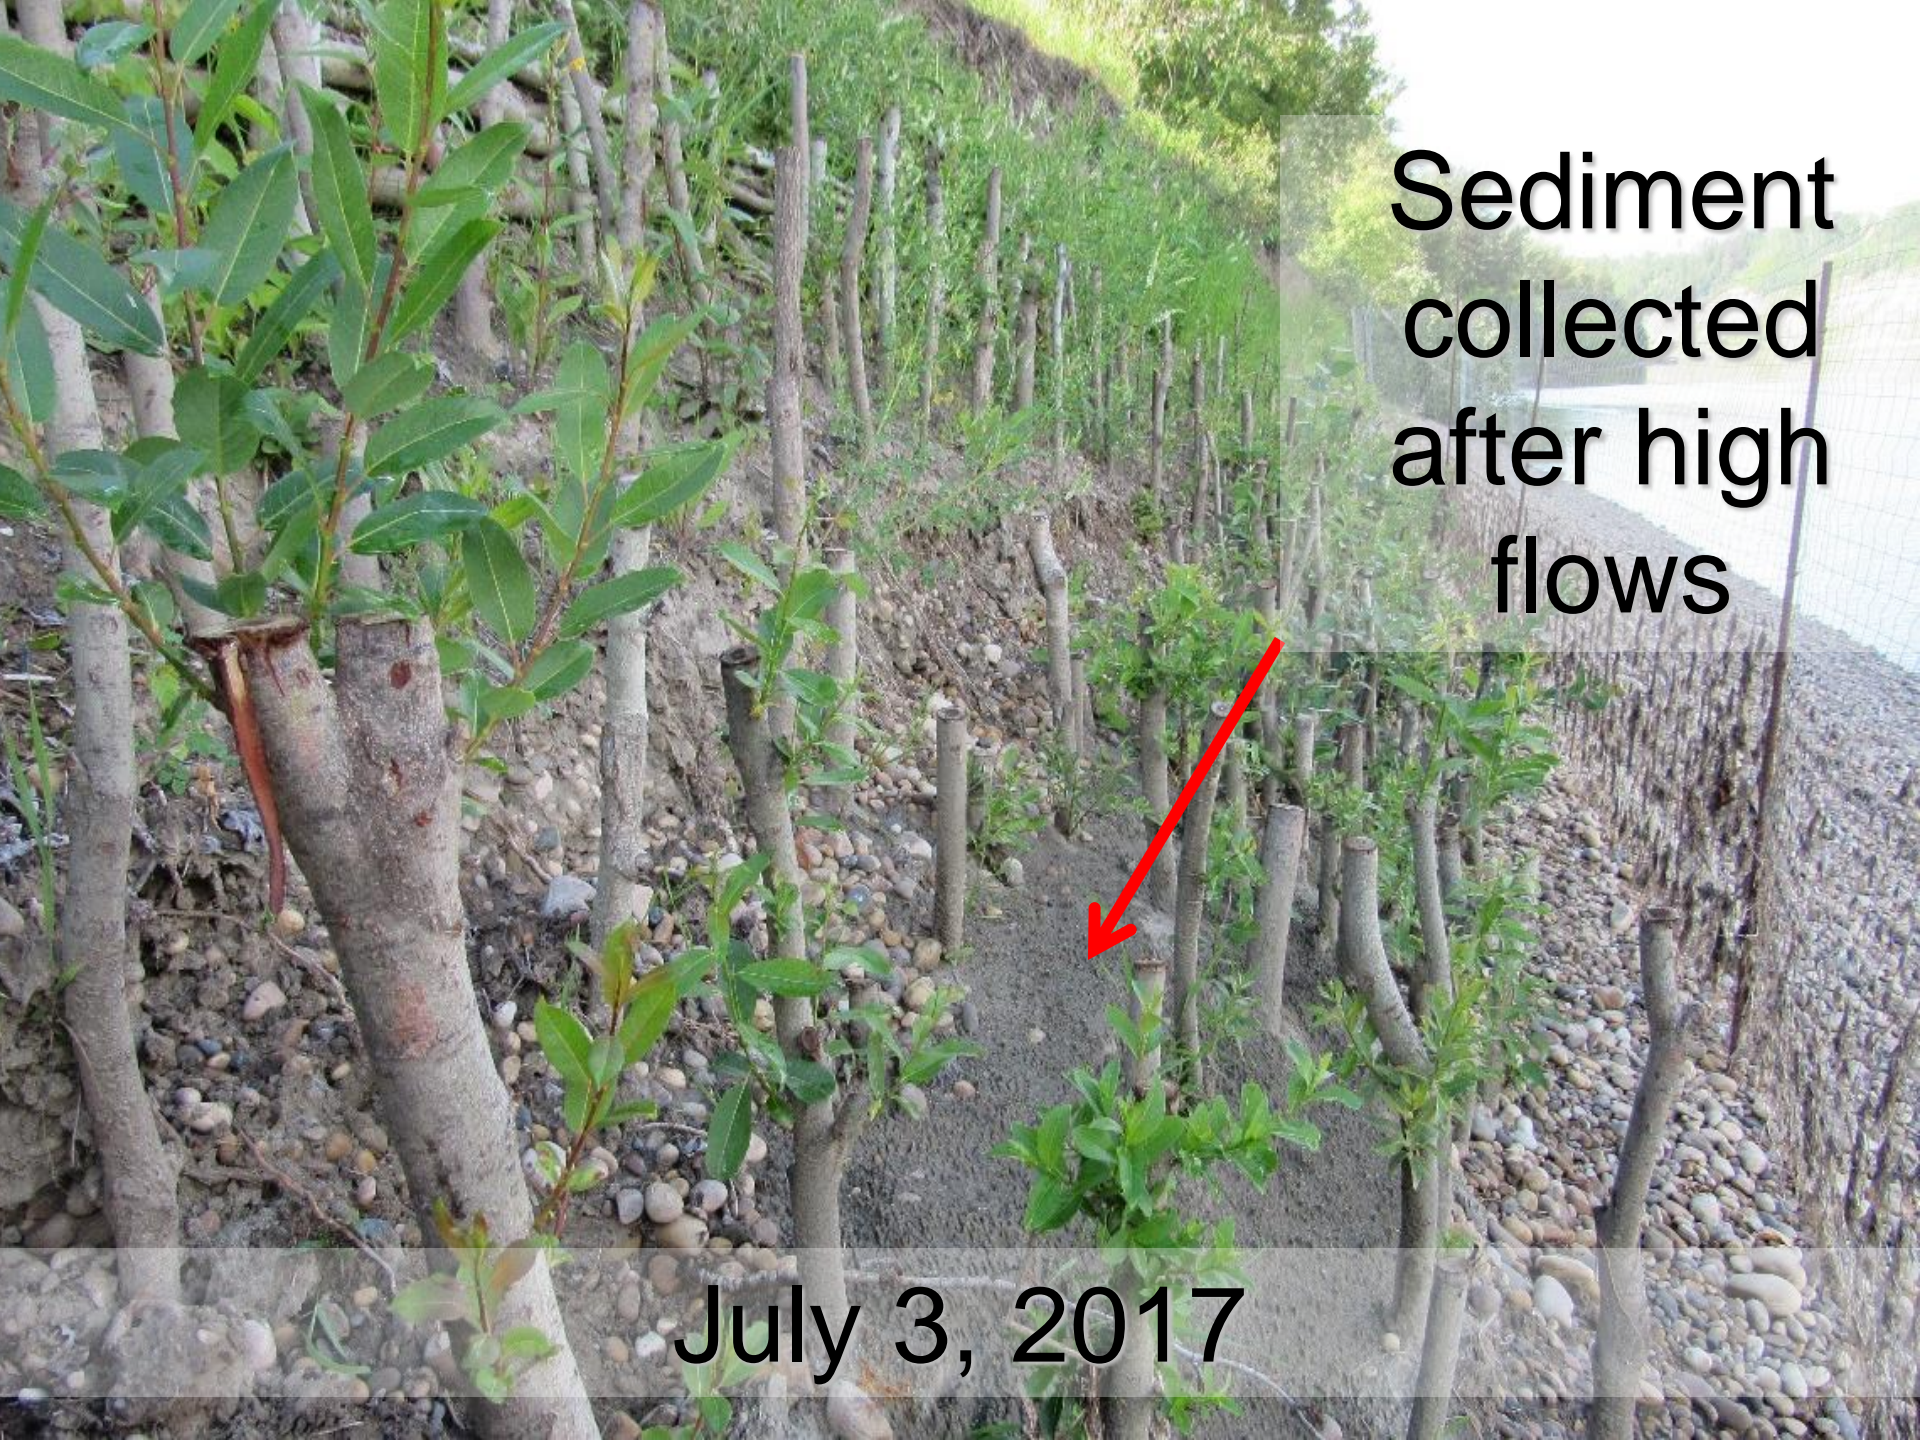
Dense Live Staking along the toe of the slope will slow the flow of the river and allow sediment to be deposited on the shore.

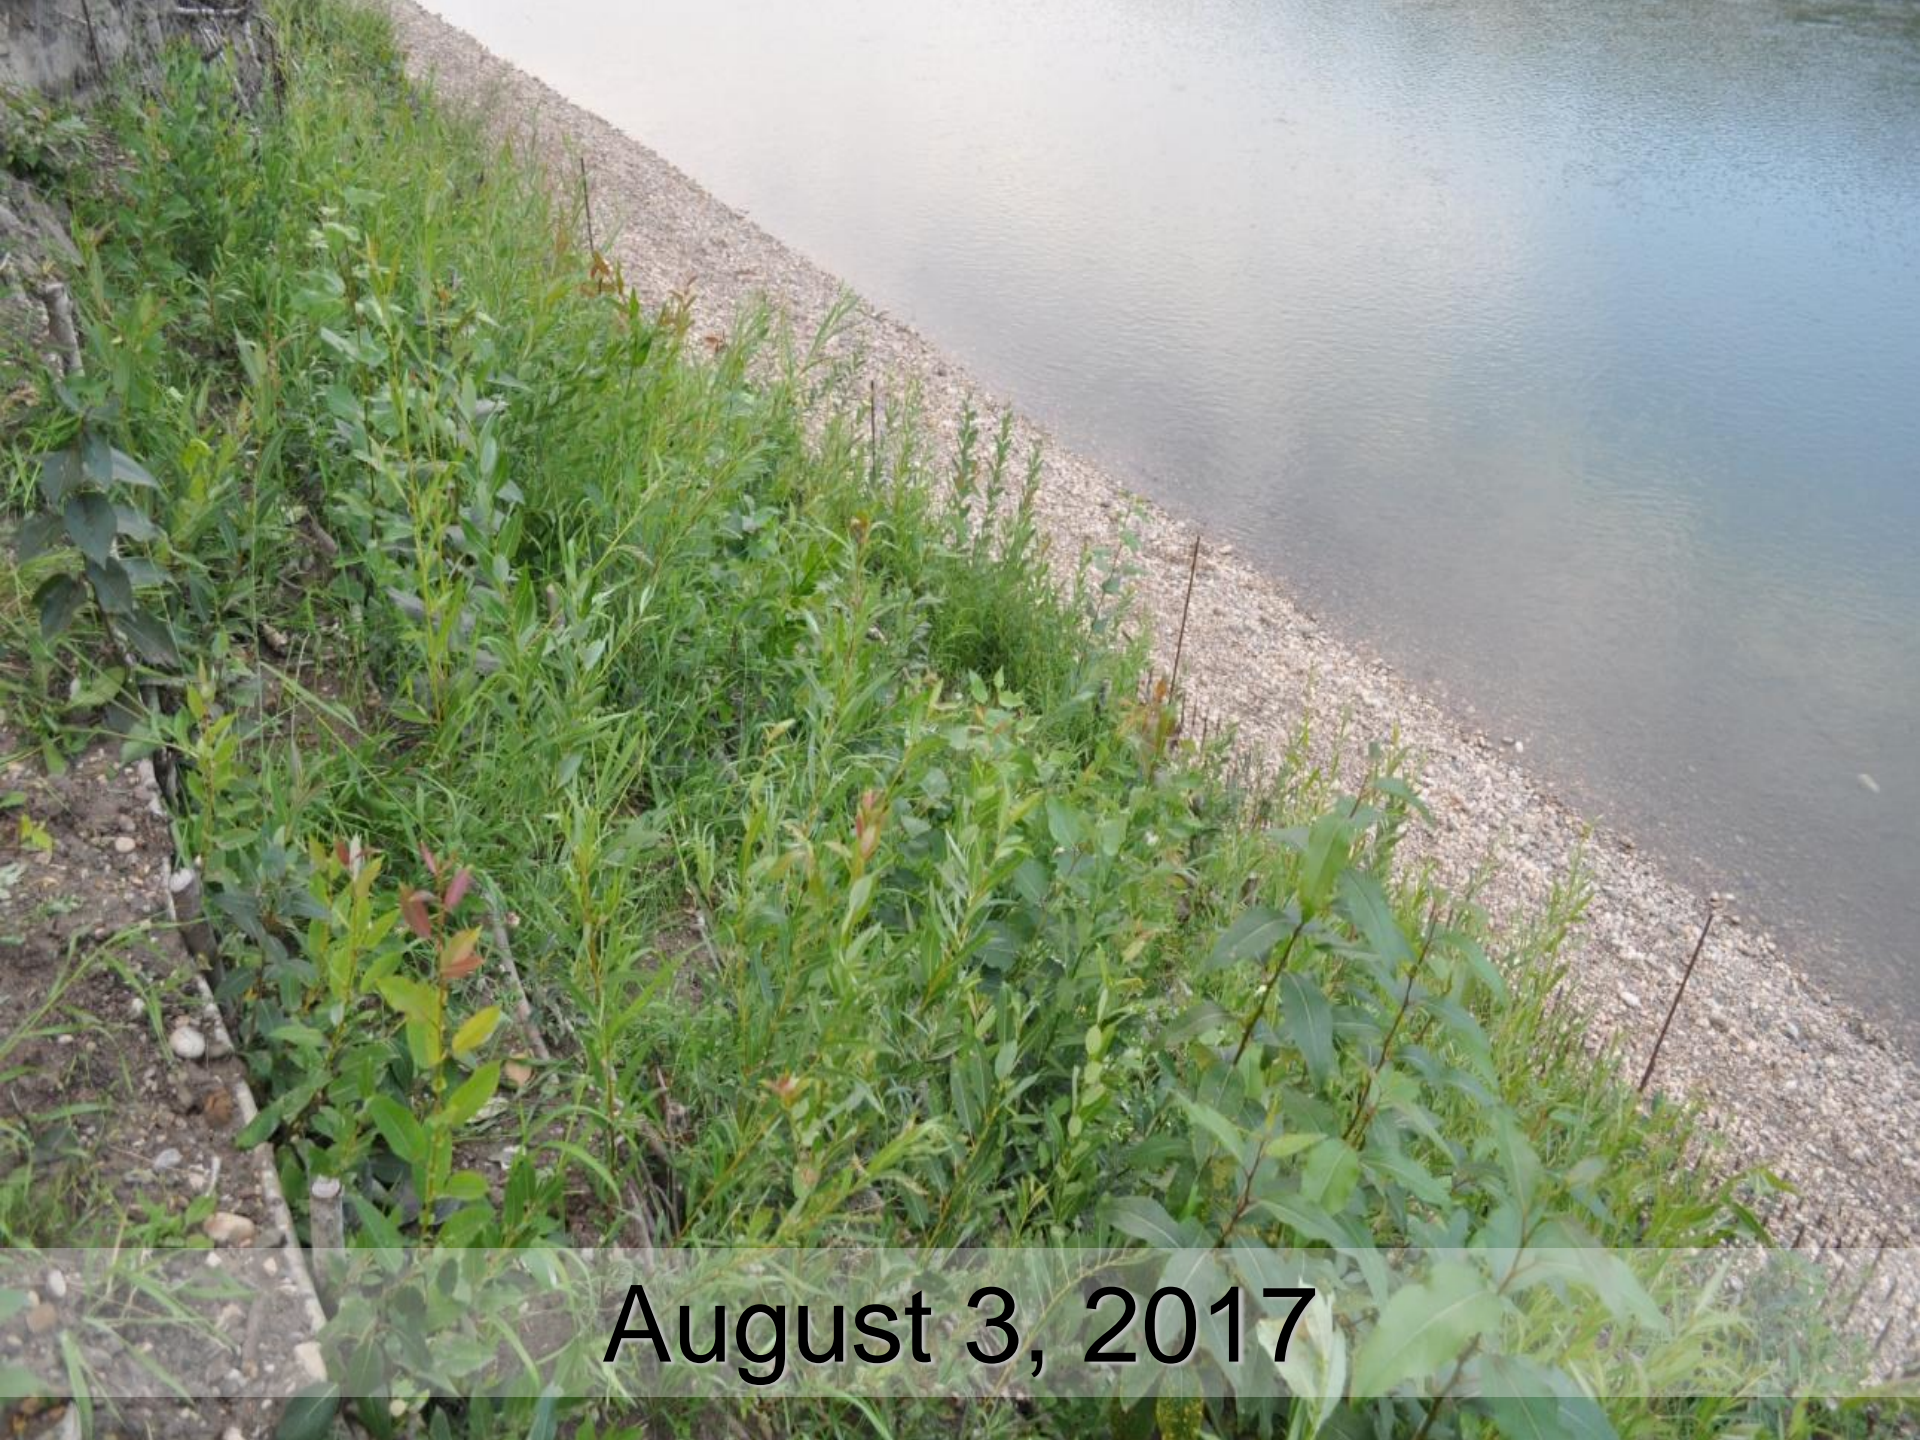
Sediment
collected
after high
flows

July 3, 2017

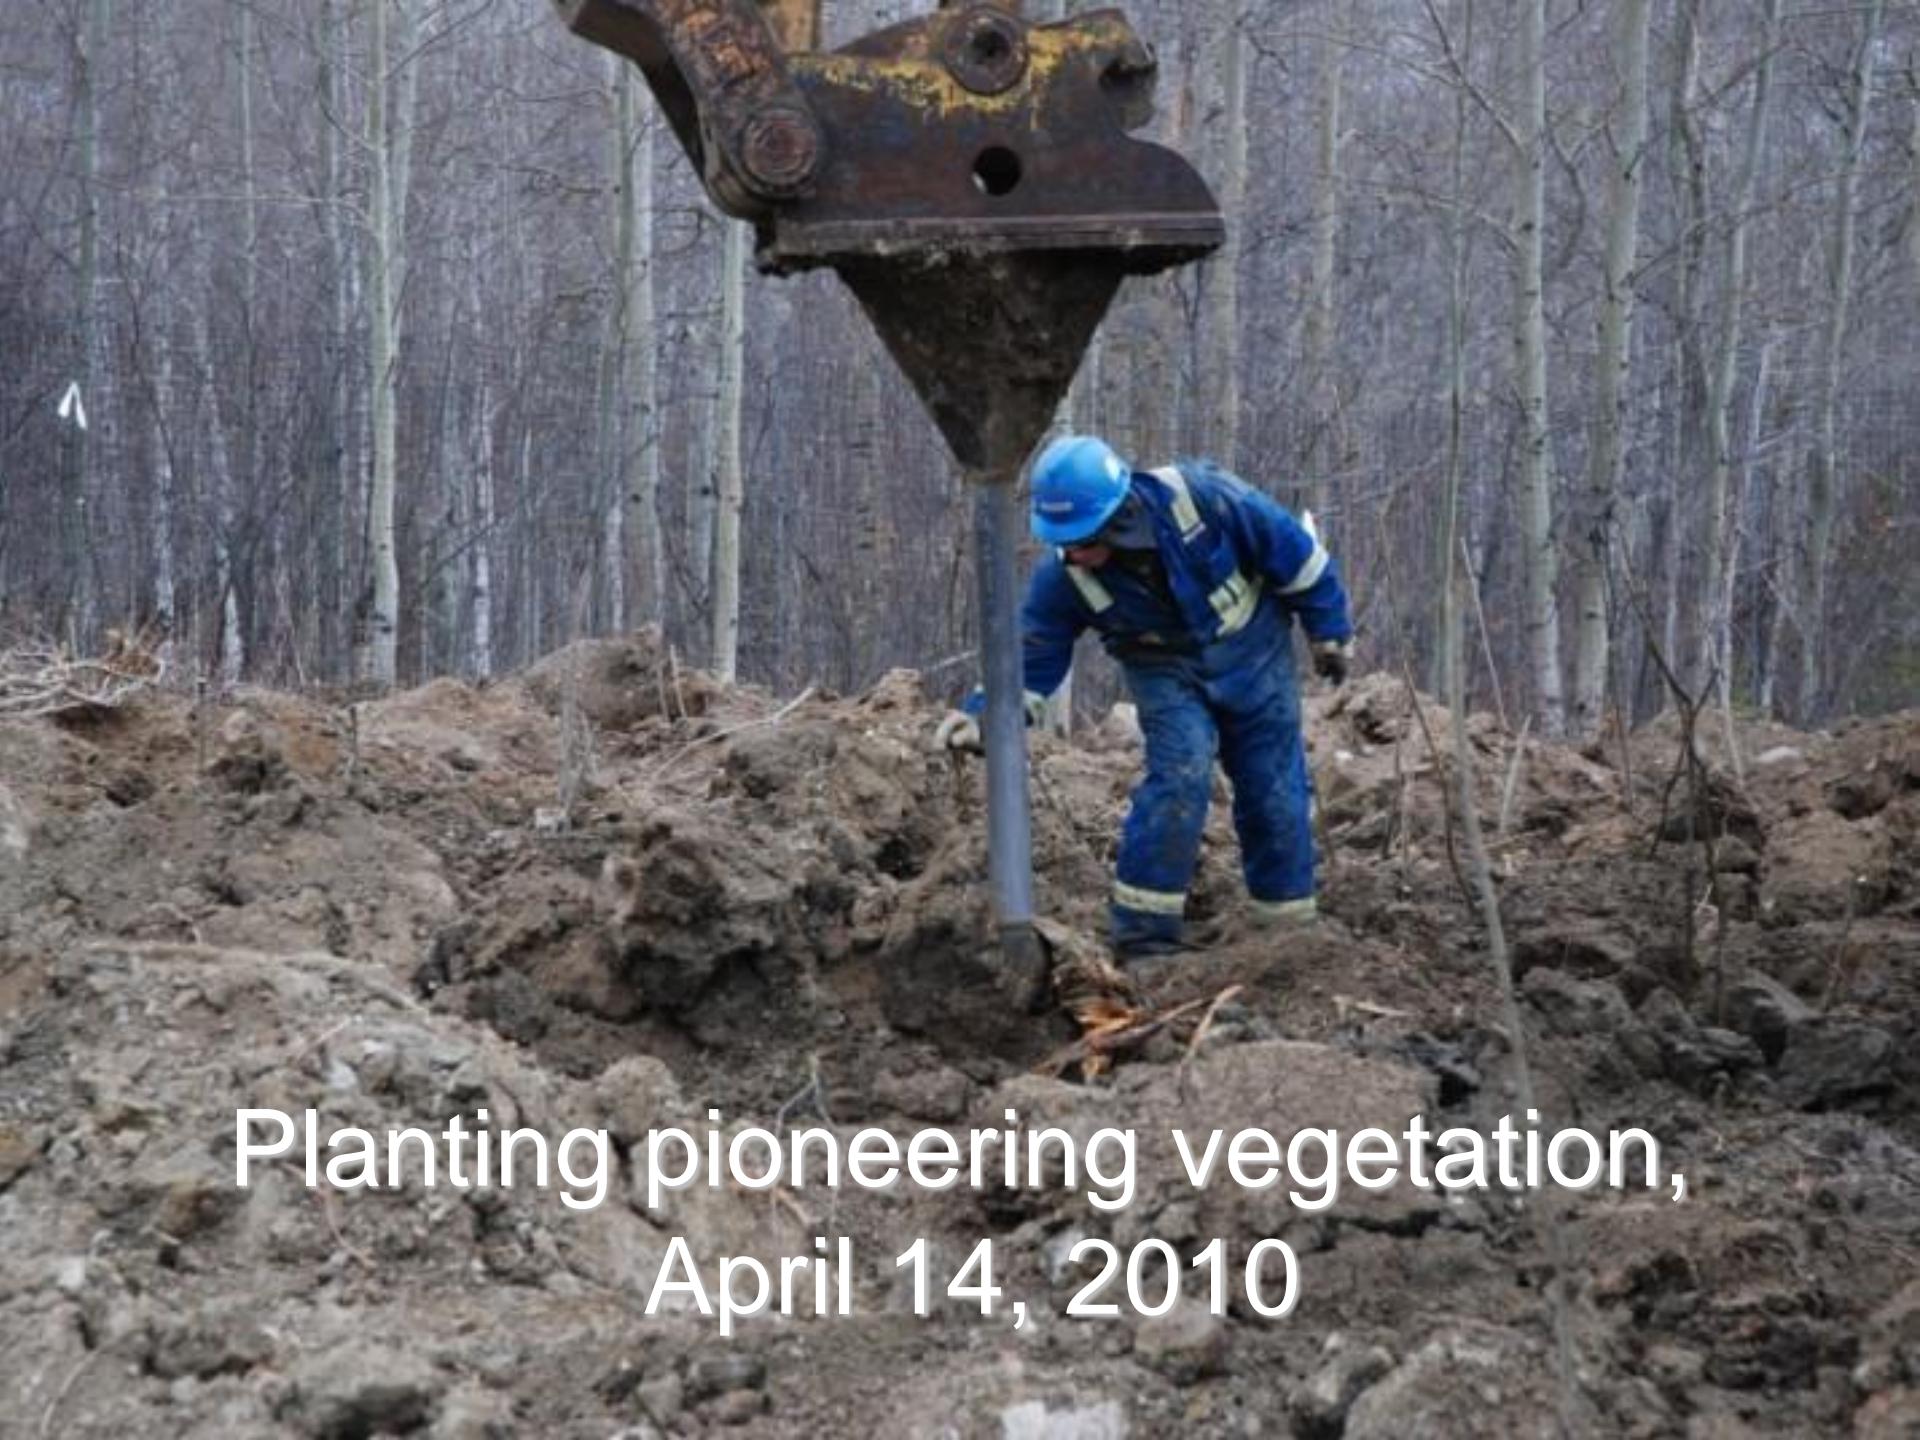
Rough and loose, April 14, 2010

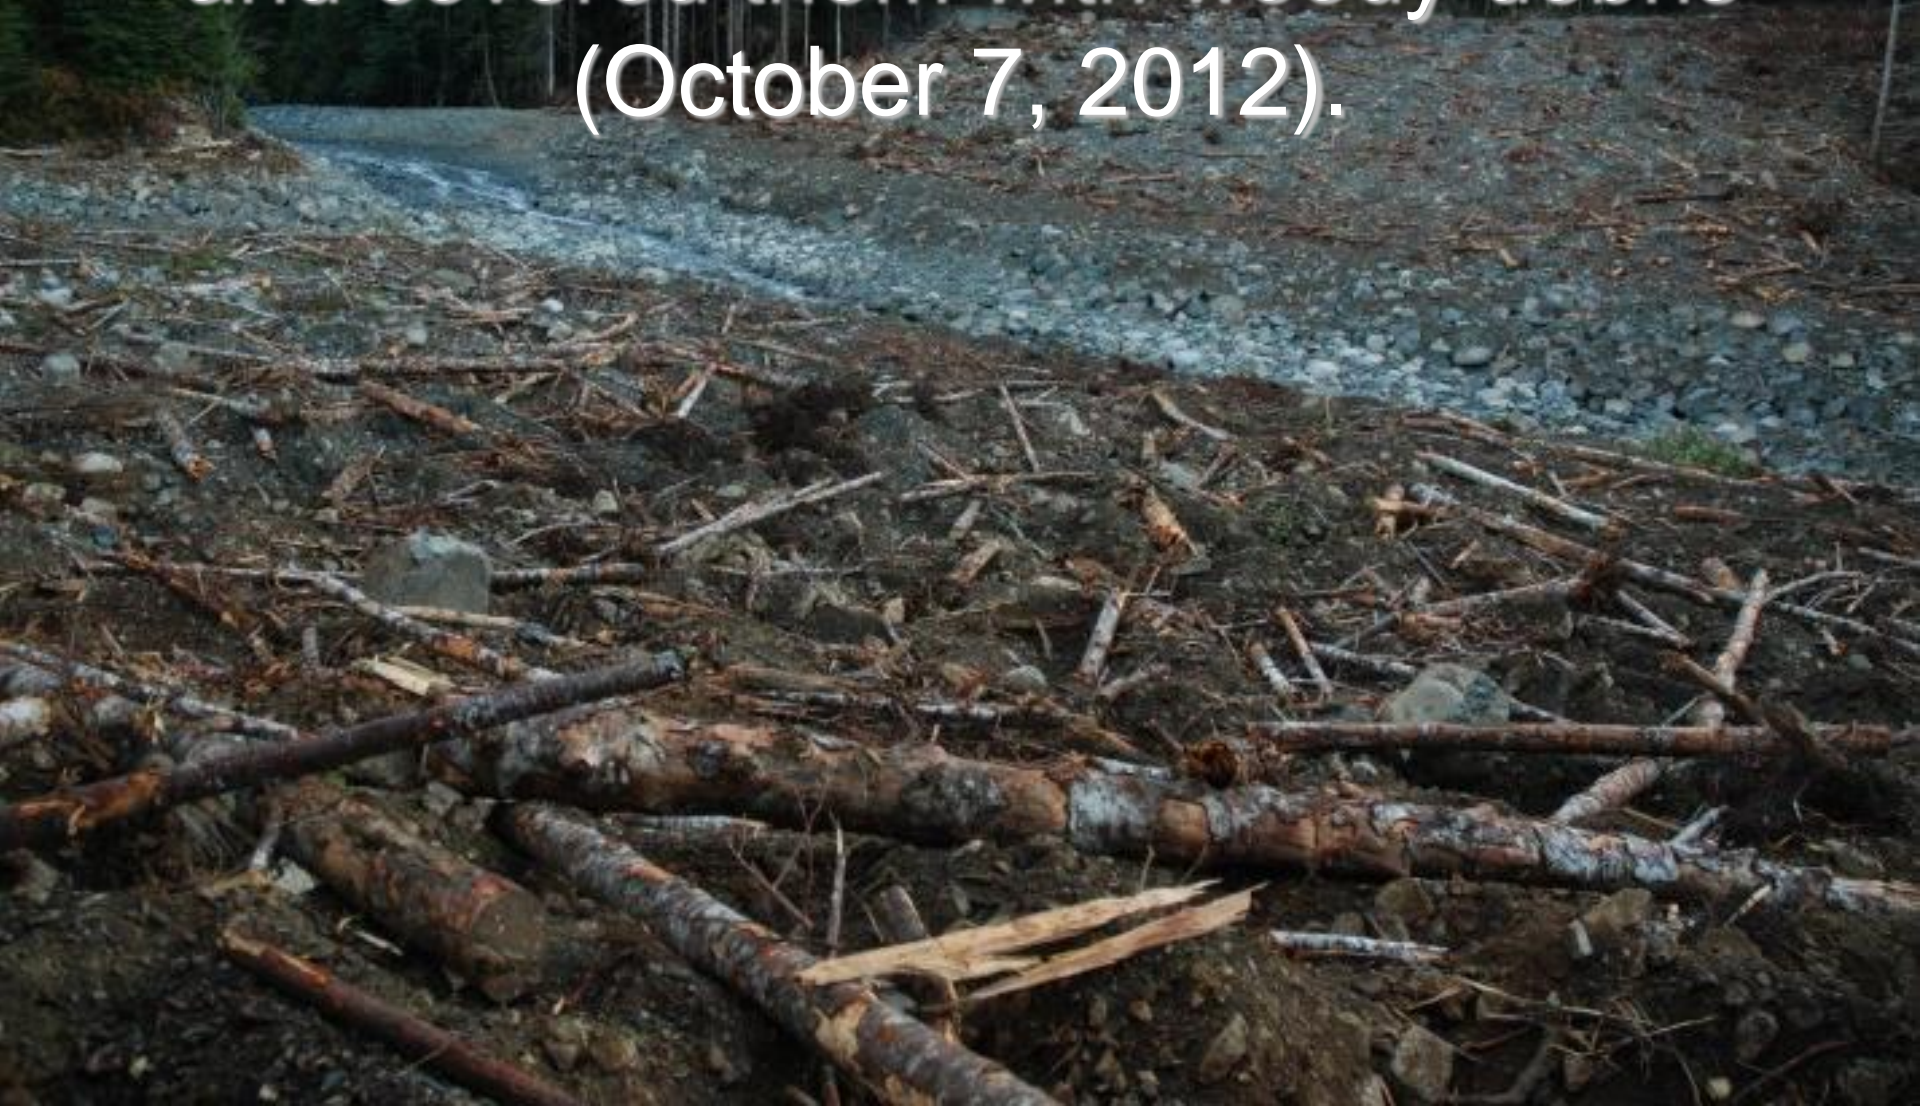
So we made project sites rough and loose
(= increased topographic heterogeneity)
and covered them with woody debris
(October 7, 2012).

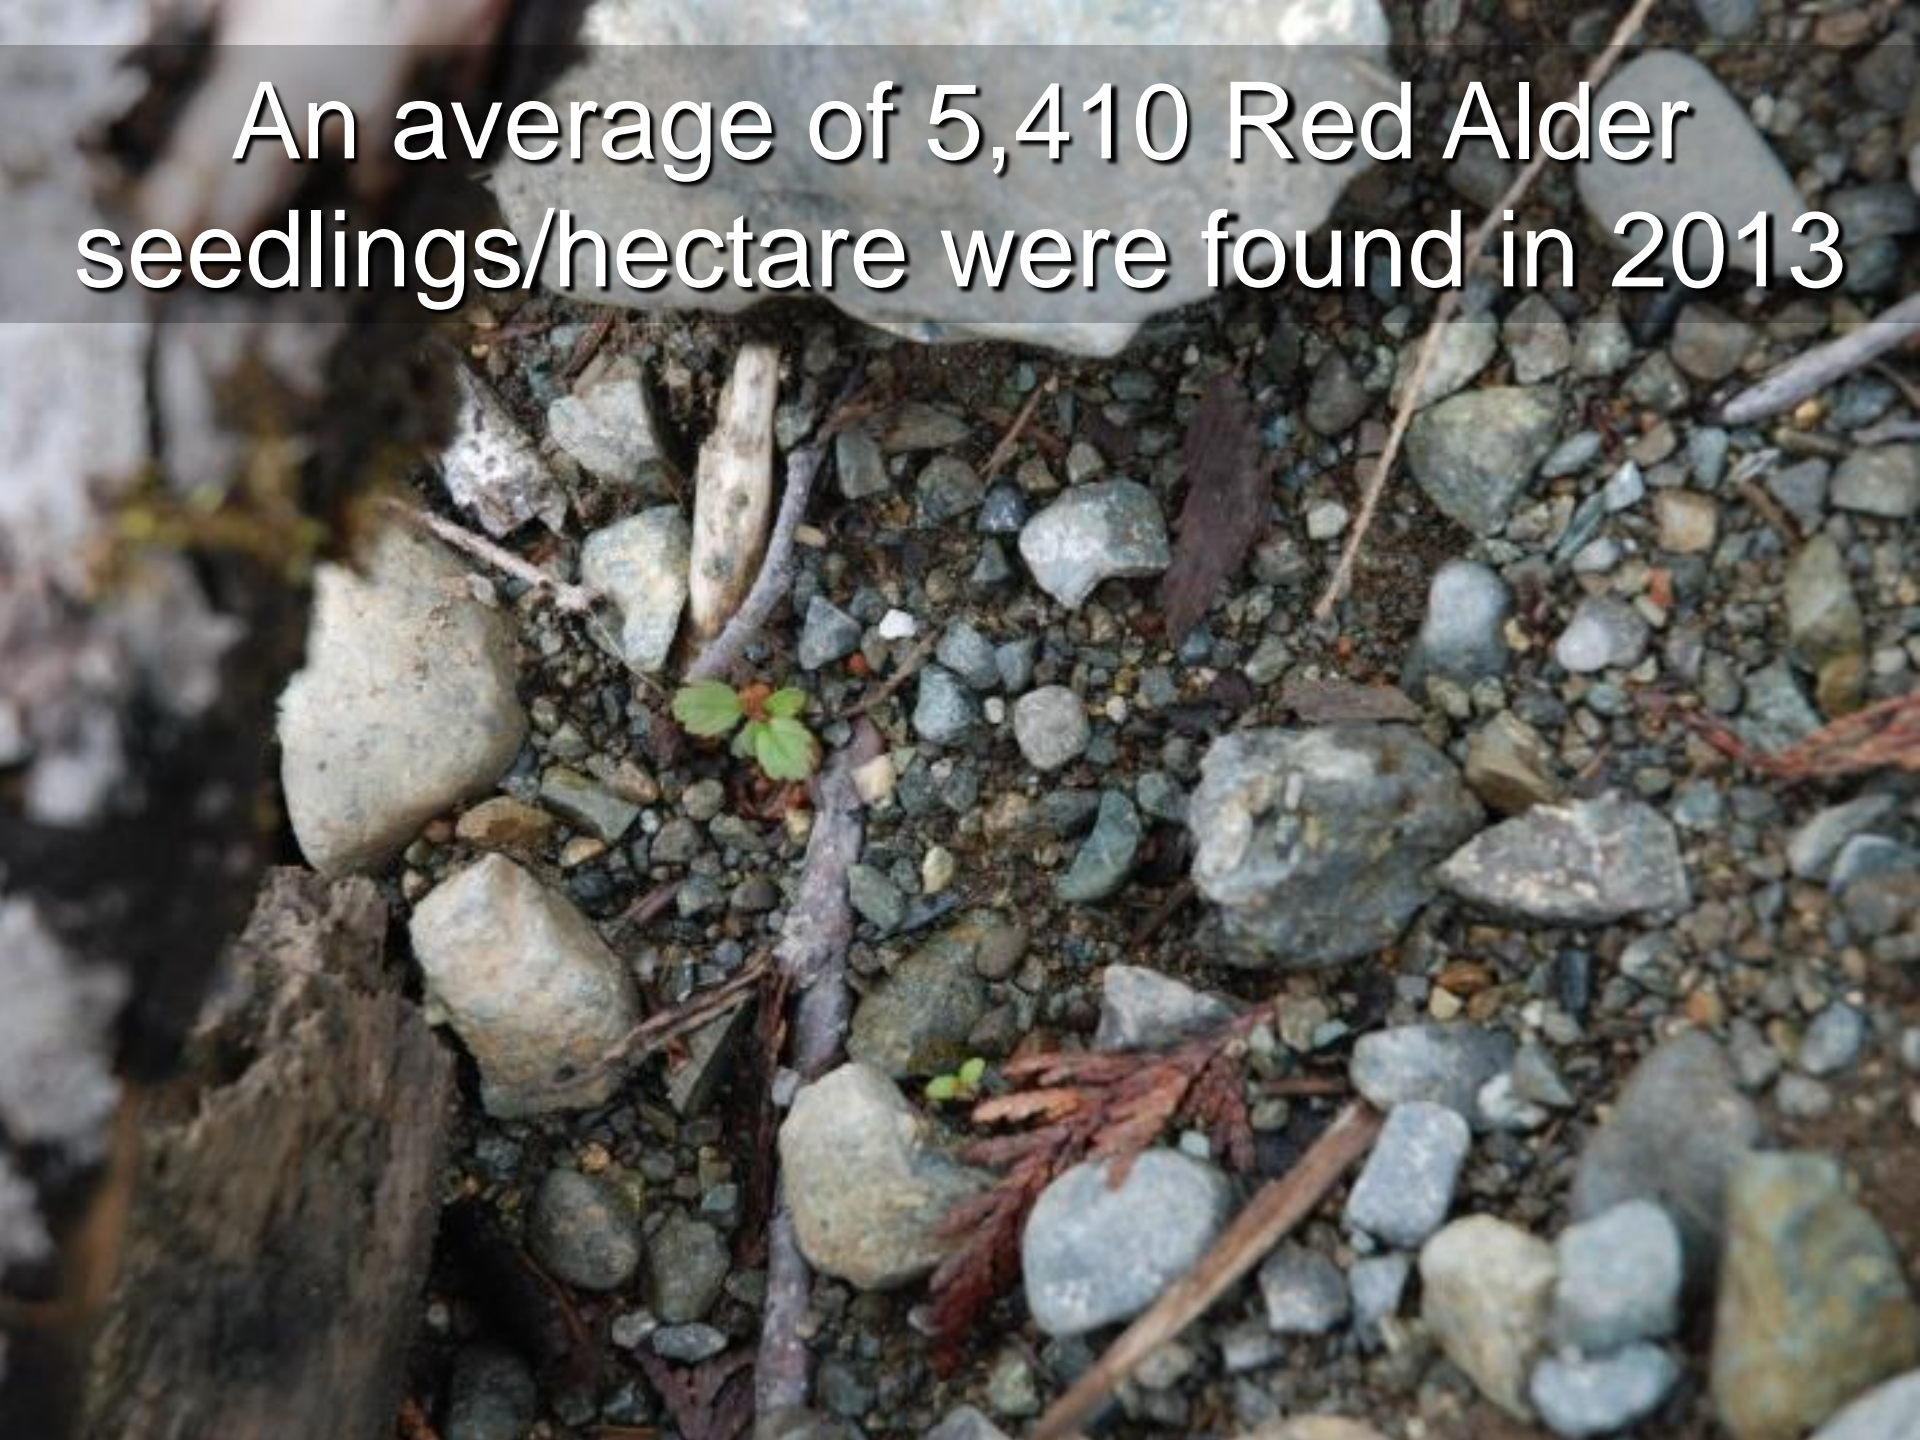
An average of 5,410 Red Alder seedlings/hectare were found in 2013

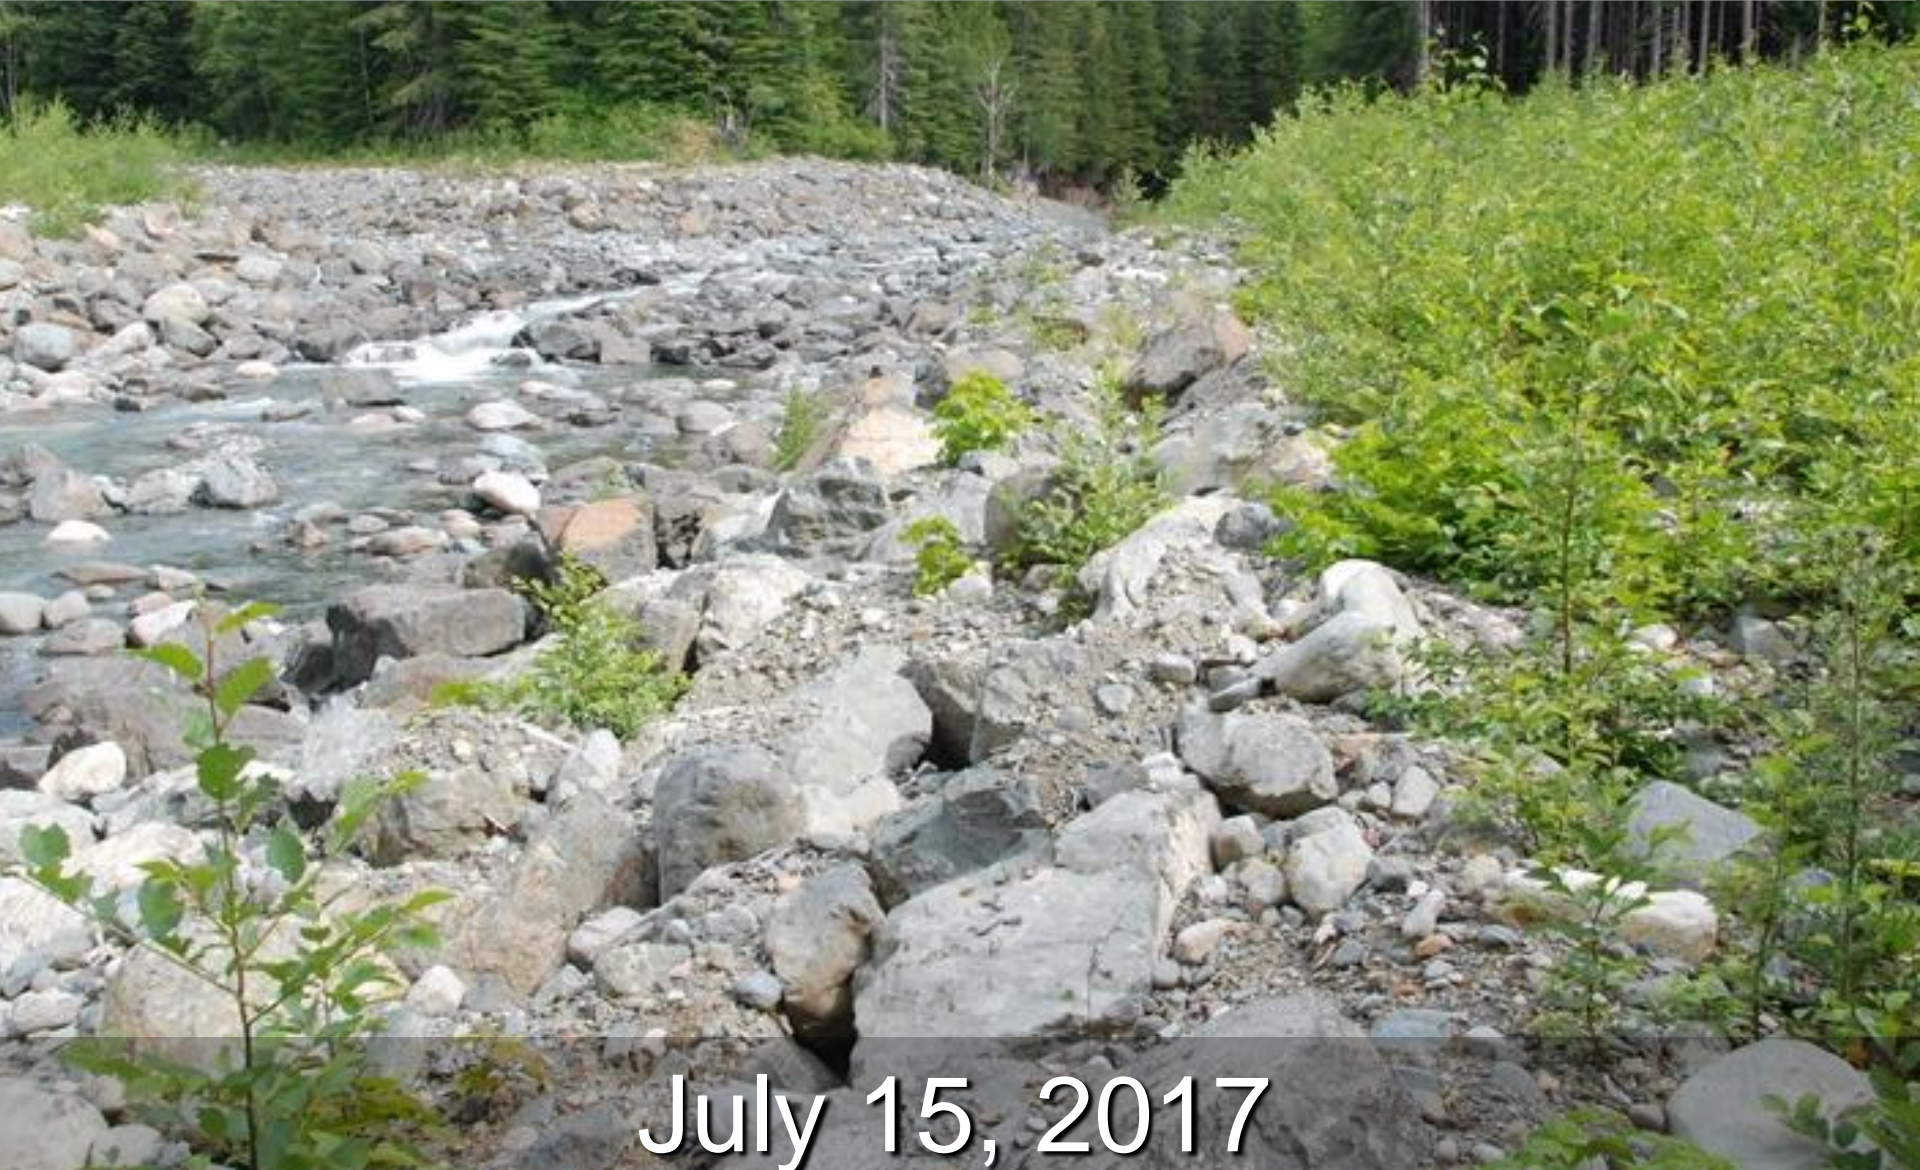
Including between the rocks of the rip-
rap

These will grow to lock the rip-rap in place

Alder are establishing in the rip-rap
along the river.
