Hydroseeding to Limit Erosion during Pipeline Reclamation

Andrew Stewart, PAg

February 2020

SASKATOON SOUTH BYPASS PROJECT

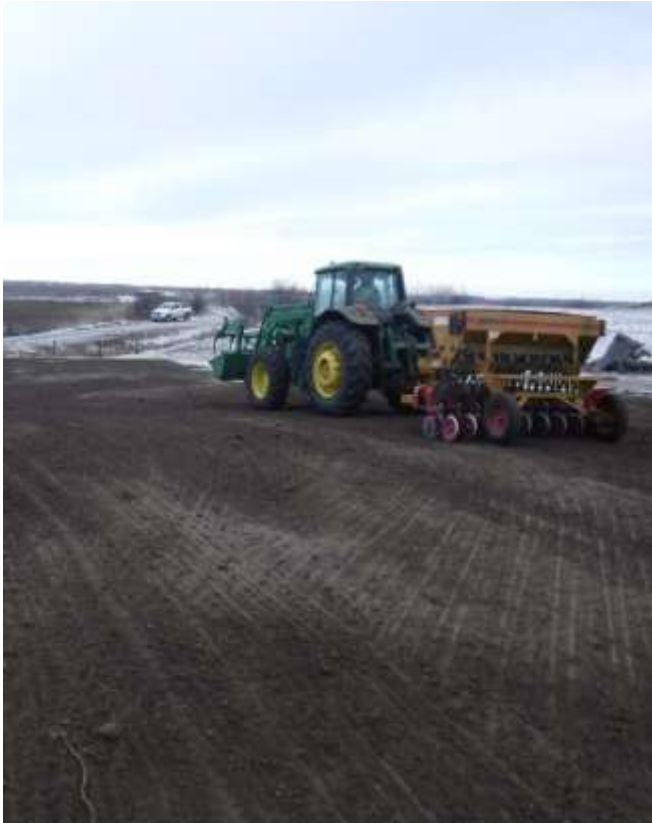
- Reclamation activities completed in November/December 2018, concurrent with construction
- Initial ROW preparation was completed by harrowing, followed by the use of a drill seeder. Native seed mix was seeded at an approximate rate of 10 to 12 kg/ha
- Fall rye cover crop seeded at 2 to 4 kg/ha in native grassland areas
- For small areas, seeding was completed by ATV and hand broadcasting

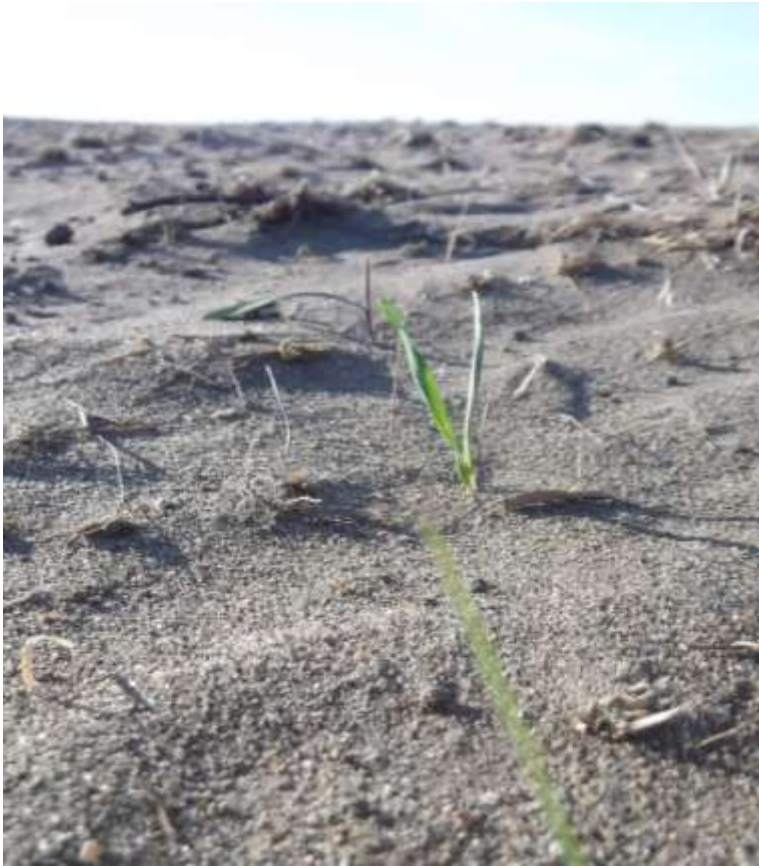
- Total precipitation for April and May less than 5 mm
- Concerns over initial establishment
- Potential for erosion loss due to dry windy conditions

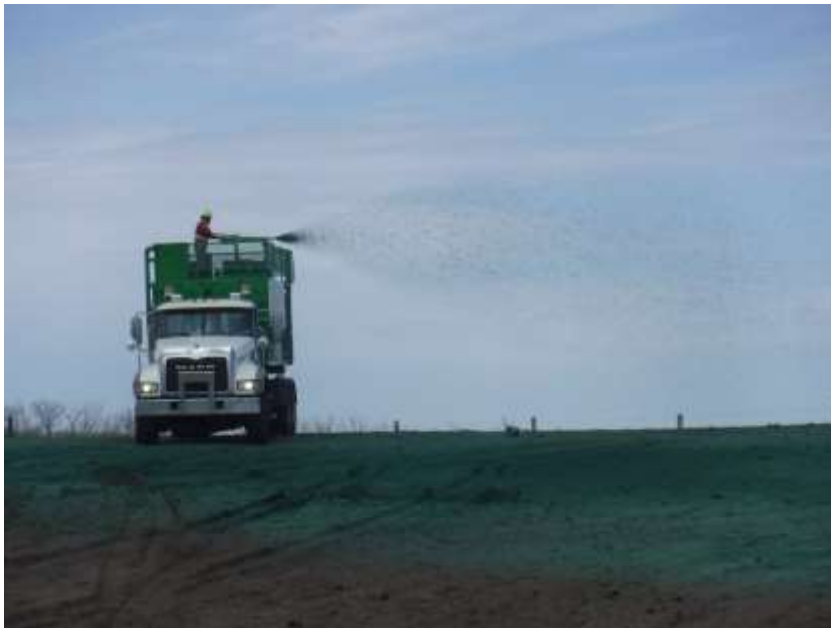
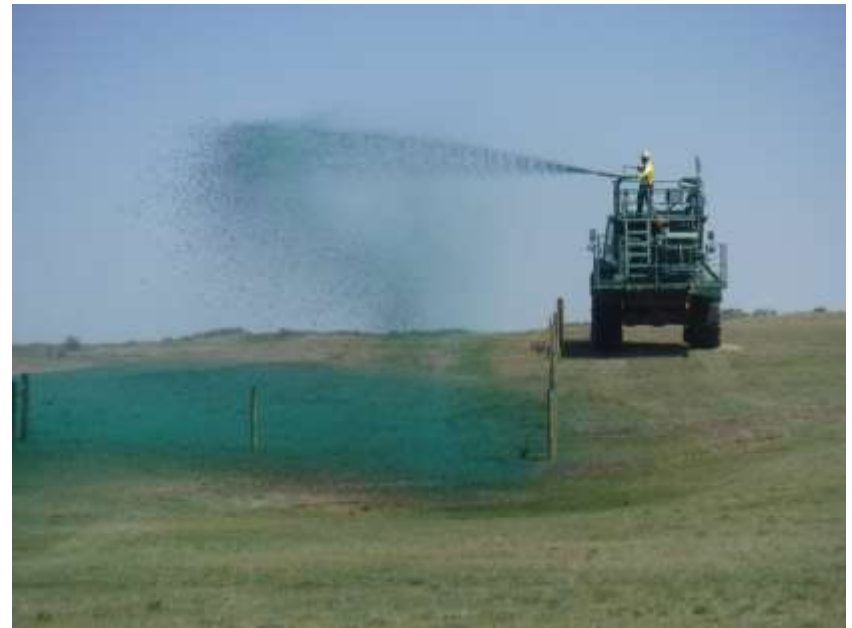
- Two different pieces of equipment used; a semi truck with a 4000 gallon tank and a rock truck modified to carry a 4000 gallon tank
- Rock truck used to move through steep sandy terrain to minimize disturbance to soil surface
- Fall rye seeded at a rate of approximately 4-8 kg/ha

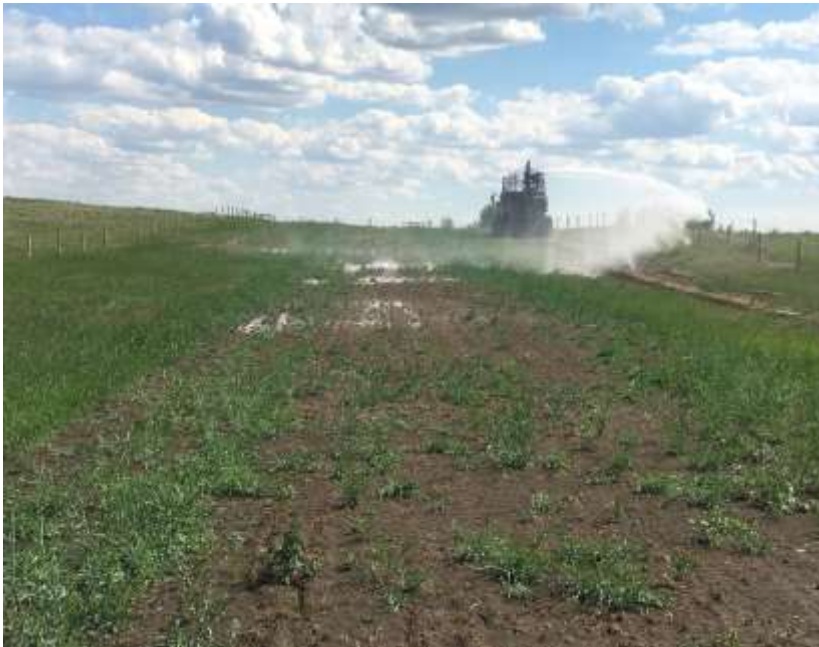
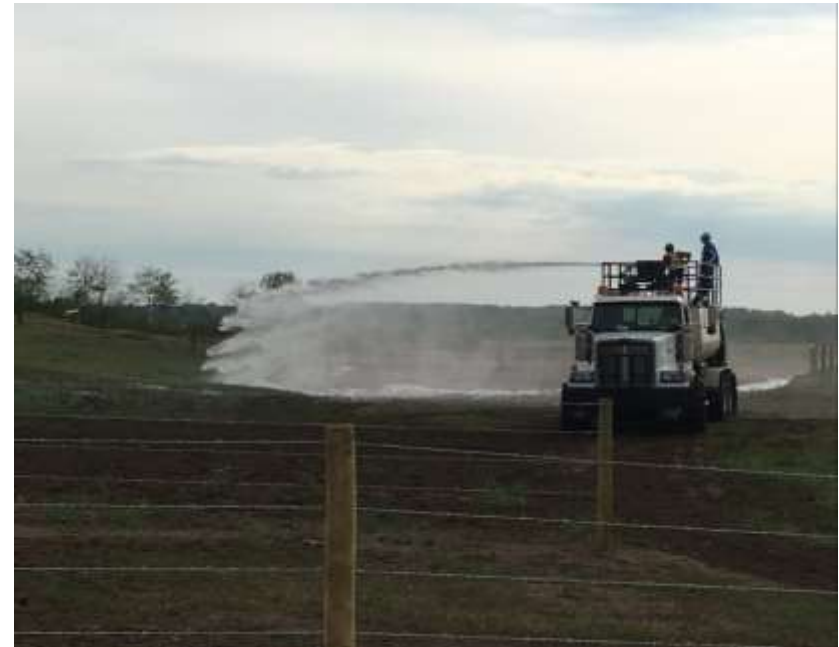
- Contracted to apply tackifier throughout portions of the ROW that were sandy and not easily accessible
- Fall rye seed that was mixed to spread at a rate of approximately 4-8 kg/ha

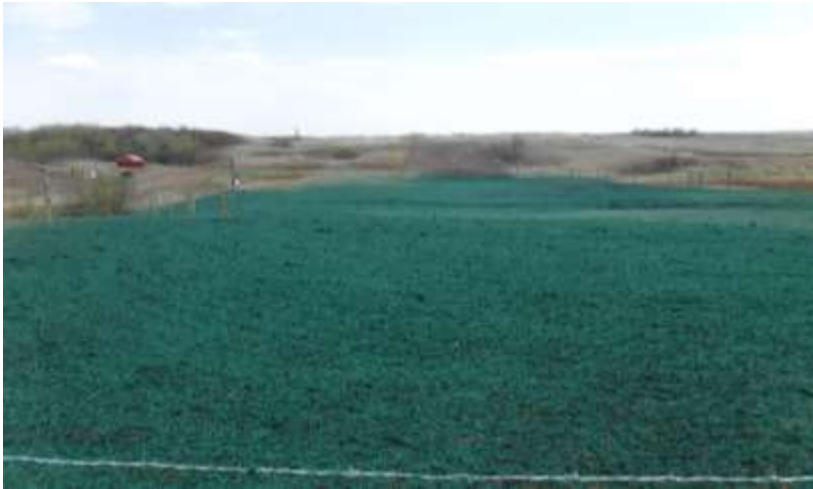
Hydromulch

- Easy to see where it had been applied
- Consistent application

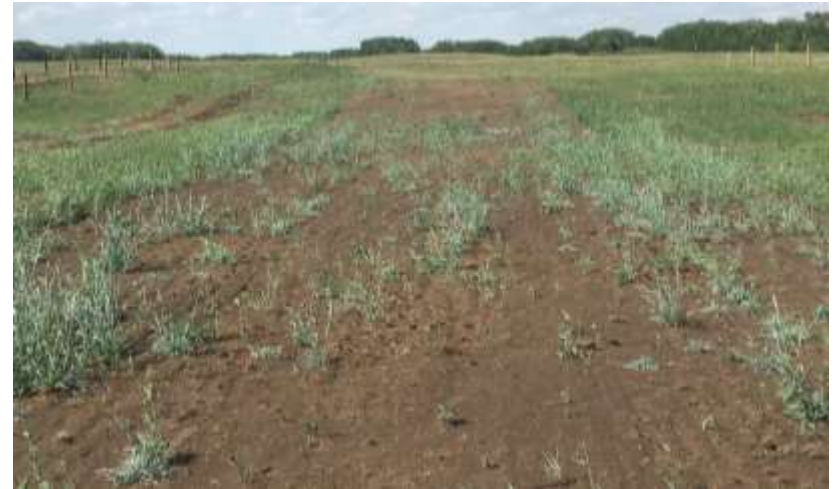
Tackifier

- Hard to see where it had been applied
- Seed application not consistently uniform

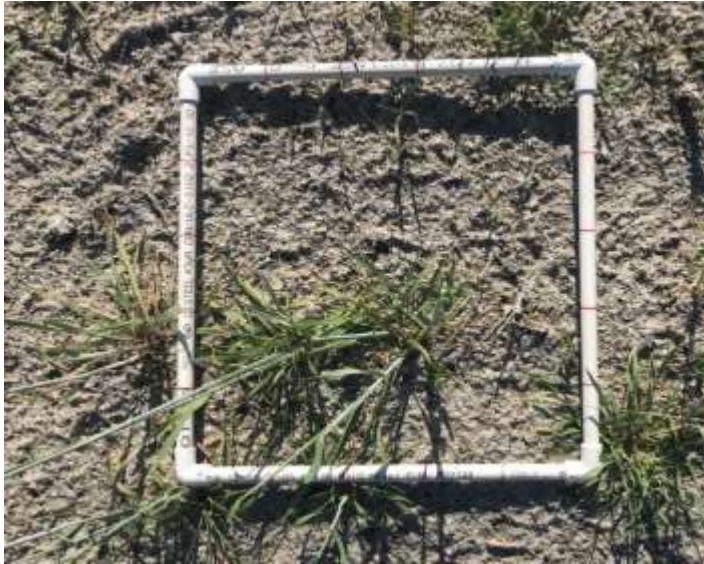
Hydromulch

- Mulch noticeably still present on soil surface
- No soil erosion observed

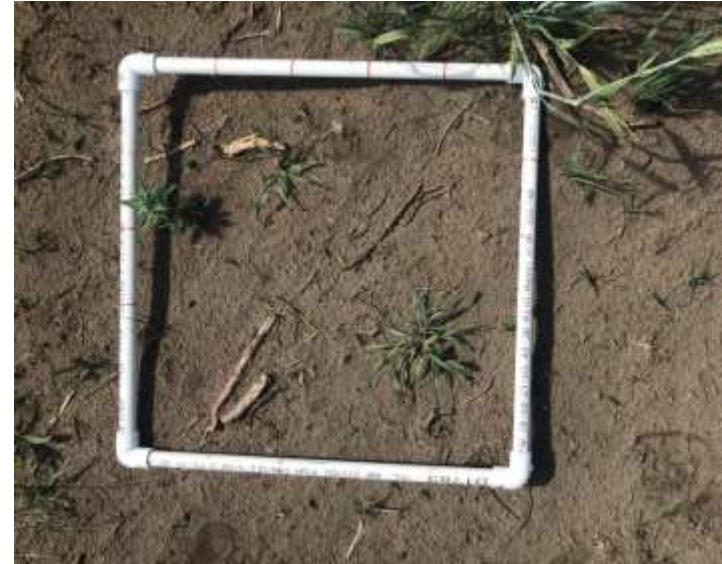
- Tackifier not visible on surface
- Little to no soil erosion observed
